October 15, 2025

Reference No. CA0012787.0623-001-RPT-Rev0

## REPORT – GEOTECHNICAL INSPECTION OF THE HAULAGE TUNNEL AT THE DUNTROON QUARRY

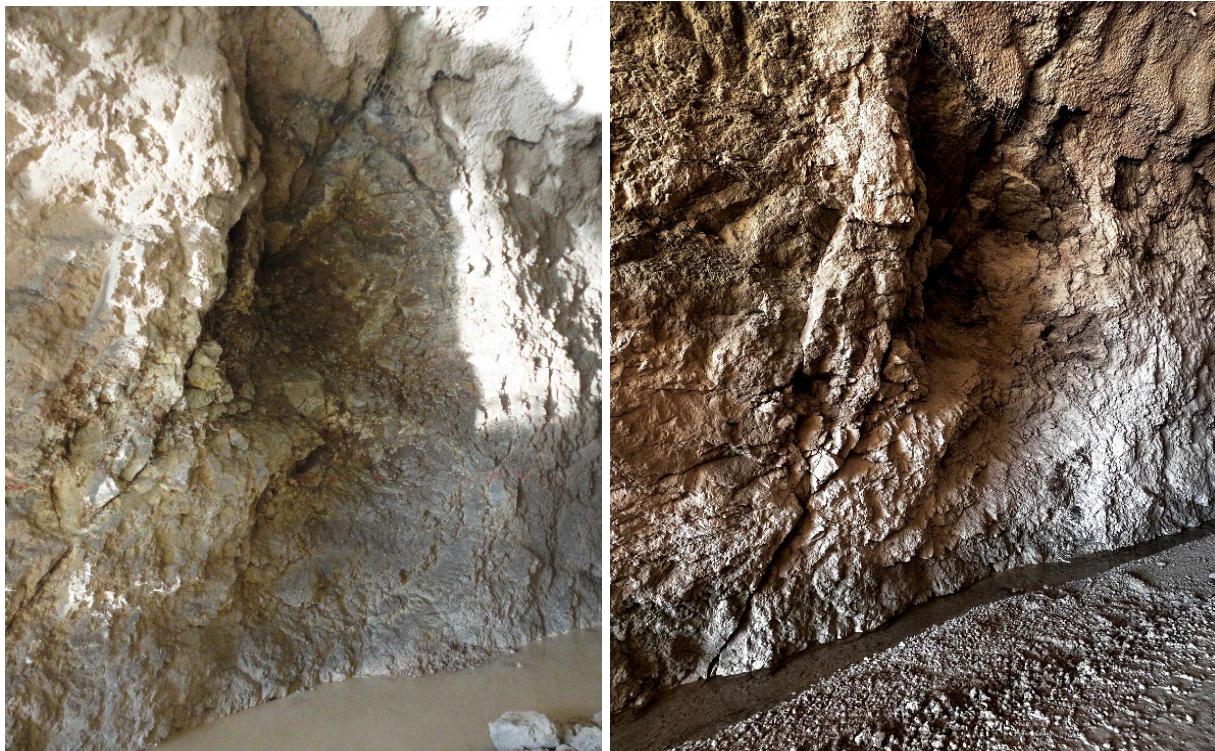
**Figure 1: Weathered rock mass at chainage 0+23 m, photograph taken in 2015 (left) and photograph taken in 2023 (right).**

- Remove all loose rocks noted along the east and the west walls as indicated on the photographs in Appendix A, and install a layer of reinforced shotcrete on west wall between chainage 0+23 and 0+28 m, and on east wall between chainage 0+19 and 0+22 m.

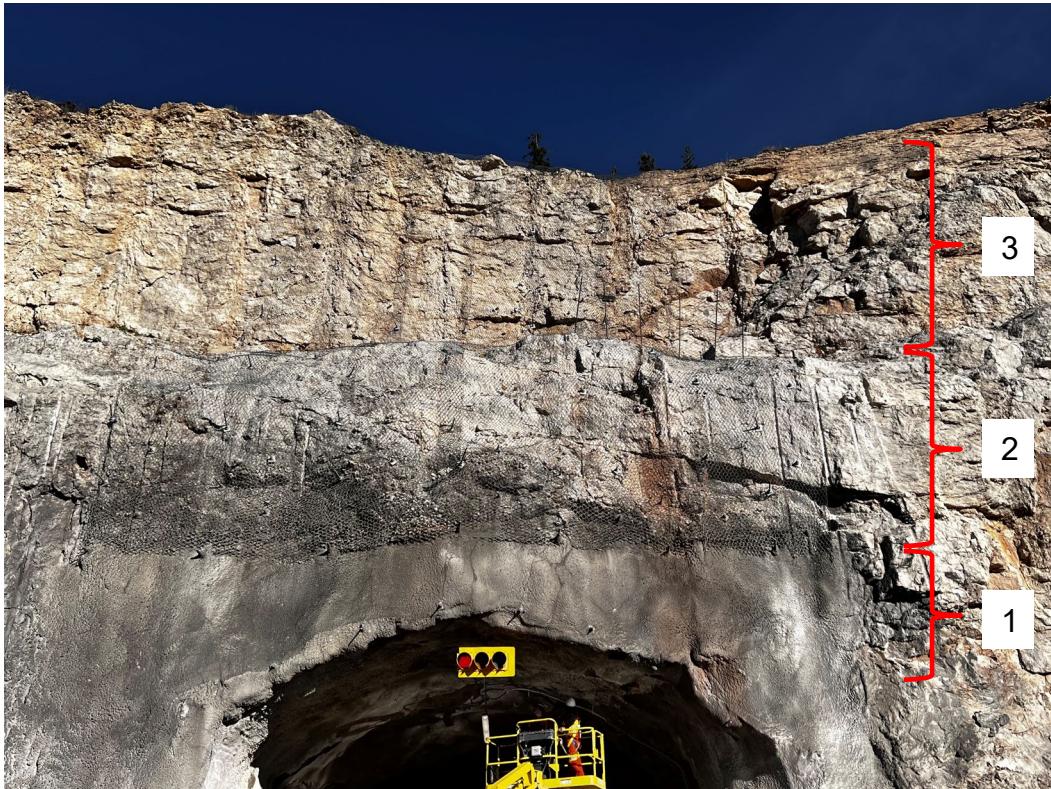
In general, the shotcrete around the tunnel entrance was in good condition (see Plate 1 in Appendix A). The portal face was dry during the inspection. Several minor cracks in the shotcrete were noted directly above the tunnel entrance that do not require remediation at this time. The exposed rock bolt heads and plates were found to be in good condition with no visible signs of significant corrosion. Plates appeared to be tight to the mesh except for one plate located close to bench on the west side of the portal (indicated on Plate 2). A significant amount of rock debris (individual pieces approx. 5 to 10 cm across) was noted to have accumulated behind the mesh particularly along the lower rock face, in the area directly above the tunnel portal. Overall, the conditions of rock faces above and around the portal appear stable. On both sides of the portal along the toe of the rockface, there are areas with accumulated rock debris. A blocky and weathered area was noted along the upper rock face in an area not covered with rockfall protection mesh. Several blocks located close to the crest appear loose and smaller overhangs on the rock faces were noted on both, the east and west side of the portal (Plate 3); however, these areas are located at a distance from the tunnel access road and as such they do not pose a safety concern for

Area directly above the portal (1) supported with reinforced shotcrete and rock bolts. Mid rock face (2) and an upper rock face (3) including the bench area supported with a mesh and rock bolts. Rock face completely dry.

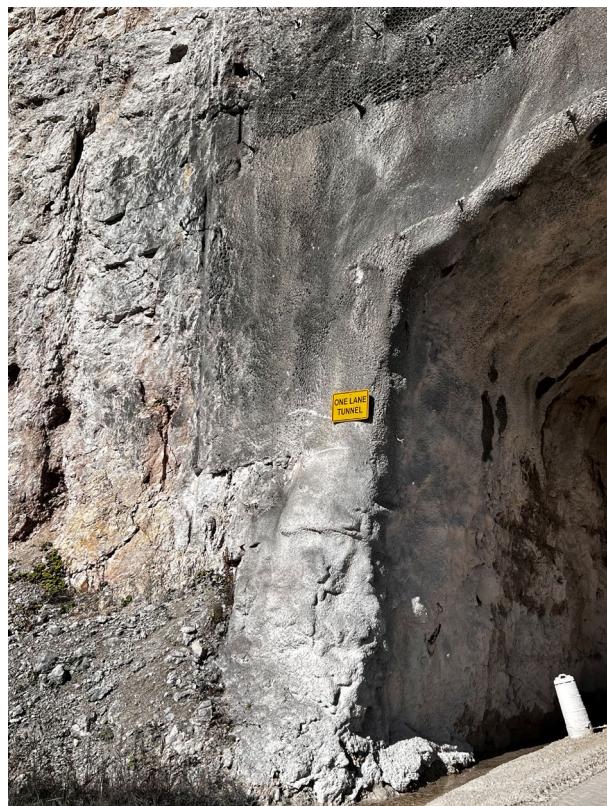
West: Shotcrete on lateral edges of the south portal face in good condition.

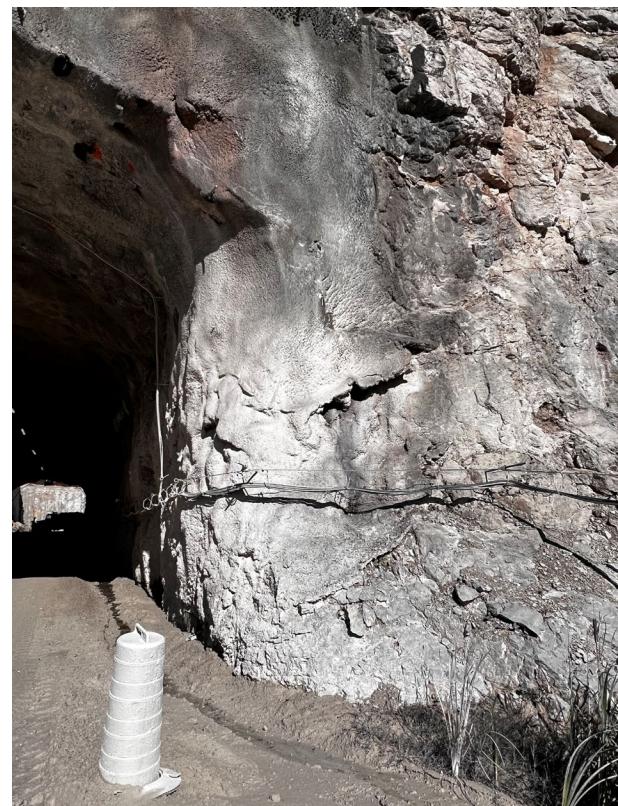
East: Shotcrete on lateral edges of the south portal face in good condition.

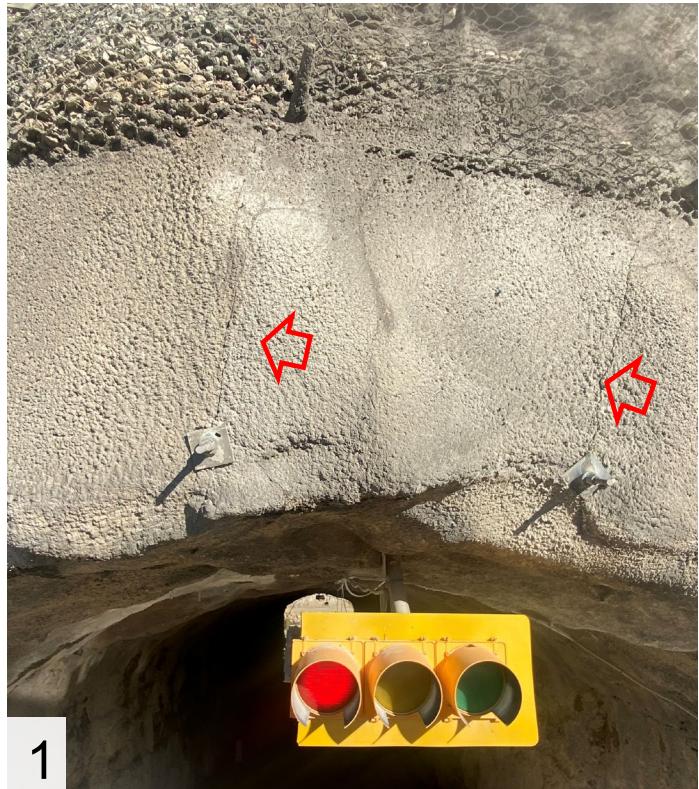
Two vertical cracks (1-2mm wide) in shotcrete above the portal..

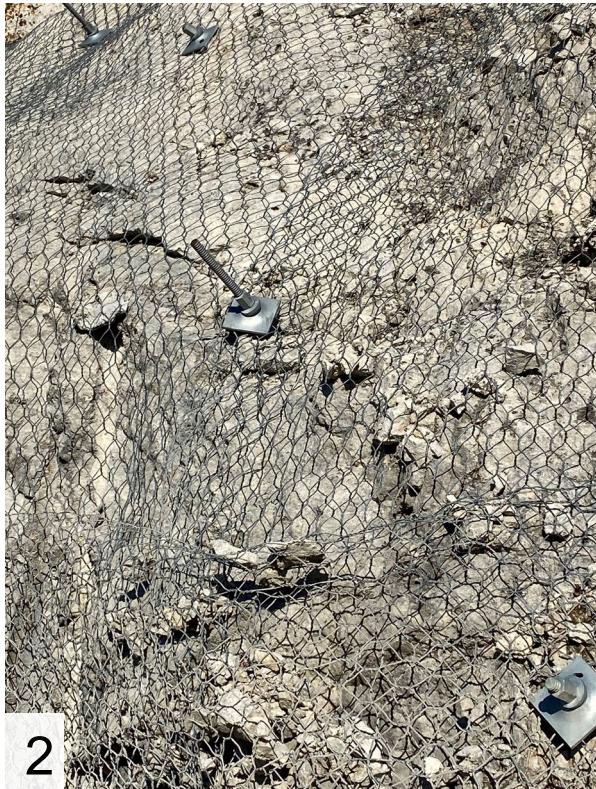
Rock debris accumulated behind the mesh.

- Remove the rock debris accumulated behind and along the mesh edges on both sides above both the south and north portal.
- Remove all currently loose, detached shotcrete along the eastern side of the north portal and re-apply a new layer of shotcrete.

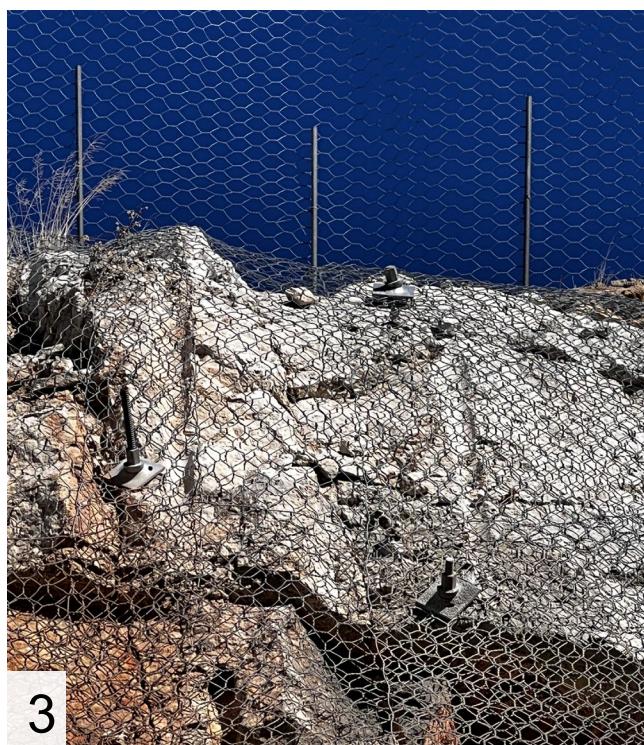
Approximately 4 to 5 m long and approximately 2 m high "mesh barrier" installed along the edge of the bench, on the east side.

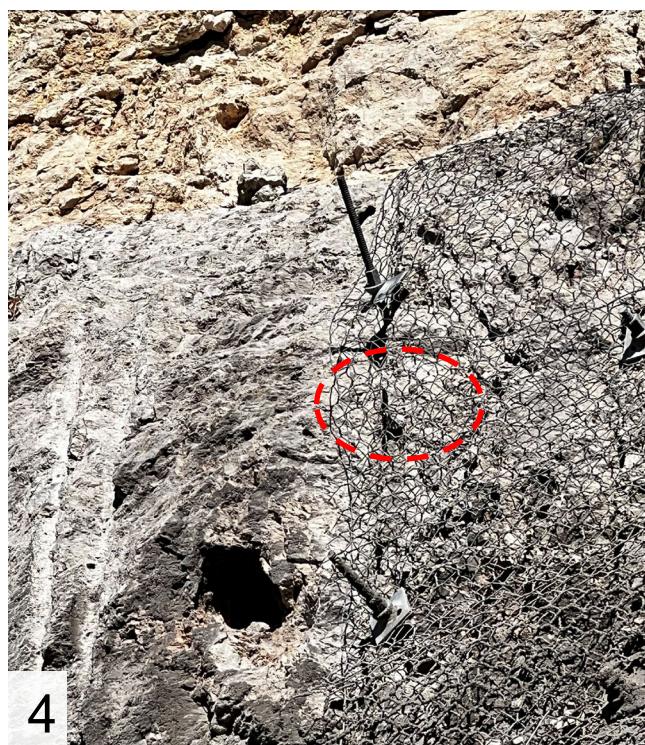
Rock bolt plate not tight to mesh on the west side

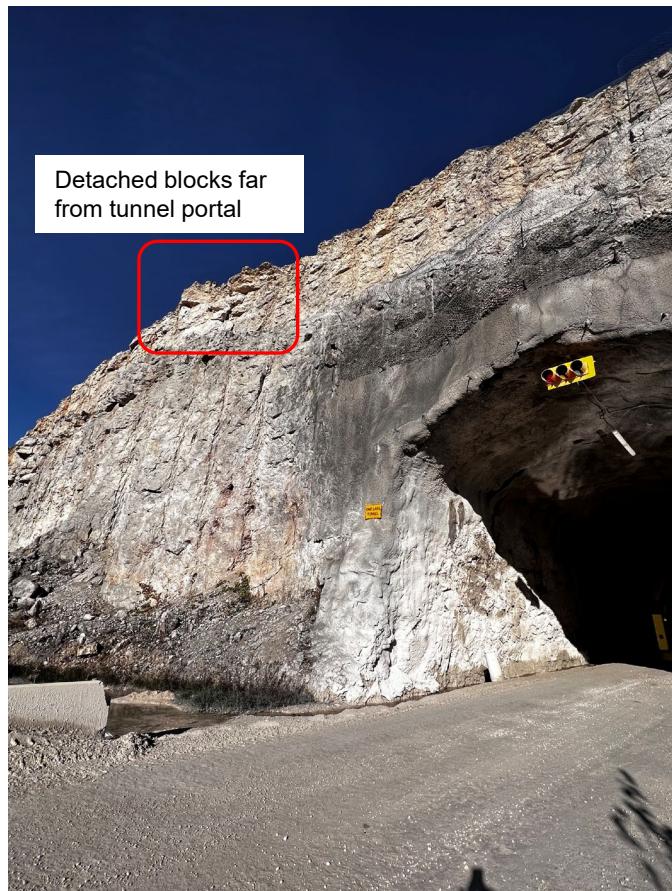
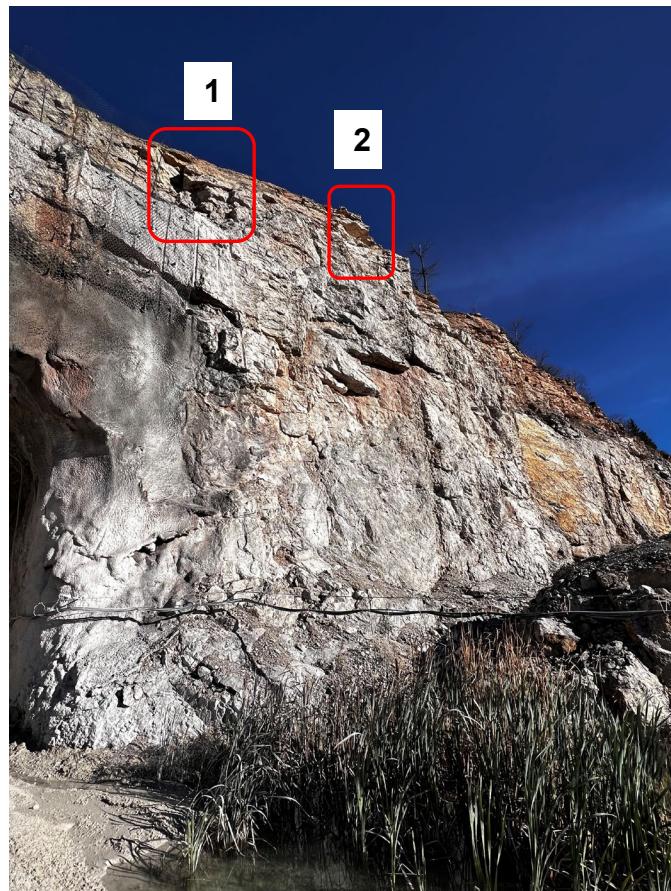
West rock face adjacent to south tunnel portal structure; vertical clean rock face with some minor debris visible at the slope toe. Some detached blocks noted close to the crest but distanced from the tunnel entrance. In case of rockfalls, they would fall directly into the ditch (filled with water) and will not have impact on tunnel traffic safety.

East rock face adjacent to south tunnel portal structure; some detached blocks noted in the upper part of rockface. 1. If these blocks are dislodged, they could be contained by the bench and a 5 m long "mesh barrier" installed along the bench edge. 2. Undercut at the crest area, but far from the tunnel portal, not impacting the tunnel traffic in case of rockfall.

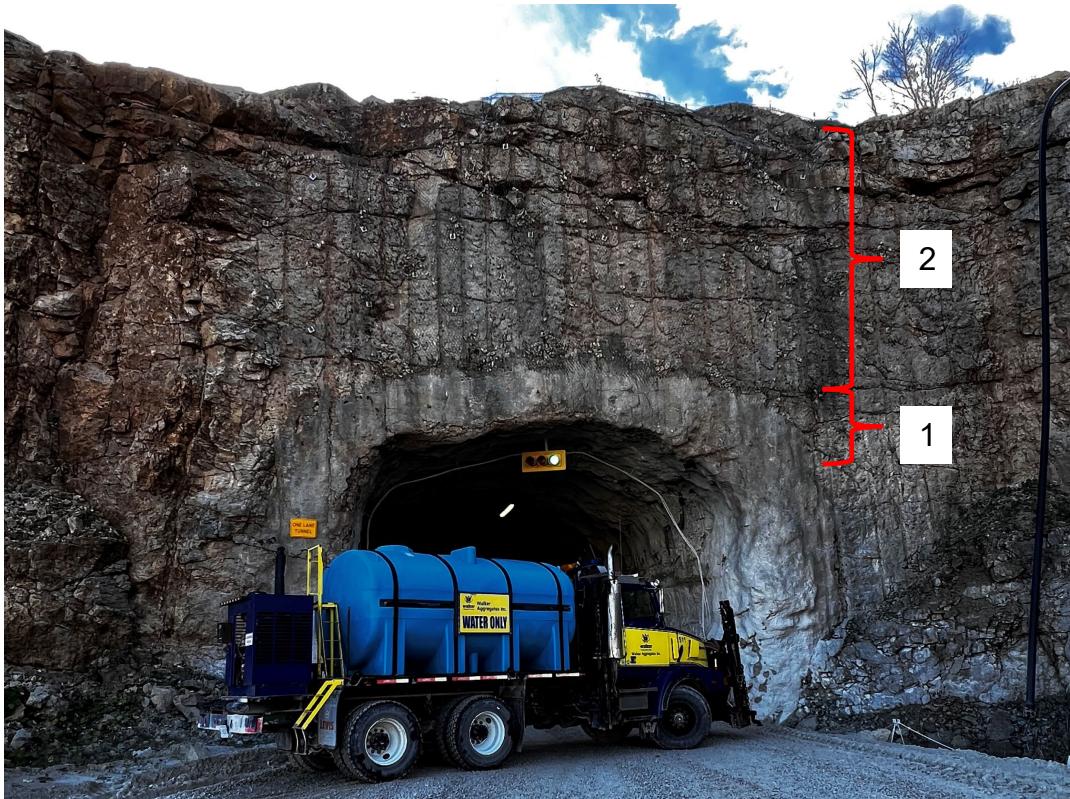
Area around the tunnel opening supported with reinforced shotcrete and rock bolts (1). Upper rockface area (2) supported with wire mesh and rock bolts. Areas along the portal with cracked and loose shotcrete, some areas with shotcrete missing. No seepage/moisture noted at the rockface.

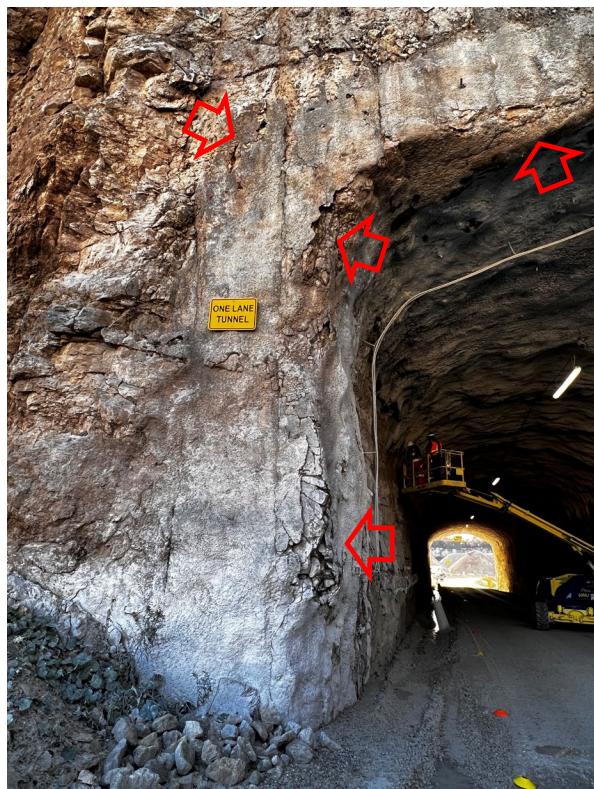
Cracking and spalling of the shotcrete, locally with exposed rock areas, was noted over much of the east side of North Portal, including the portal brow area, while the shotcrete on the west side of the portal was in fair to good condition (see Plates 4 and 5). The portal face was dry during the inspection. Consideration should be given to removal of any loose and cracked shotcrete and covering the areas of exposed rock with a new layer of shotcrete. Rock bolts installed along the rock face above the tunnel portal were in good condition. All rock bolt plates were observed to be tight to the mesh and no visible signs of corrosion were noted on the bolt heads. A considerable amount of rock debris was noted behind the rockfall protection mesh along the entire rock face. Large overhanging blocks, located along the crest area, were also observed; however, these blocks appear to be stable. The rock face to the east, adjacent to the portal area, has undergone significant weathering such that a significant amount of rock debris has accumulated at the toe of the face (Plate 6). There is a rockfall hazard potential from this area due to the quantity of loose blocks which may dislodge with the possibility that some of the falling material could bounce or roll towards the haul road. Consideration should be given to cleaning the accumulated rock debris at the toe of the rock face and installing a concrete jersey barrier at the entrance to the tunnel to prevent blocks from reaching the haul road. The rock face on the west side is nearly vertical and fairly clean with a smaller overhang below the crest that currently appears stable. The rock face parallel to the haul road is considerably more weathered with many loose blocks evident. Potential rockfalls from this area are currently not considered a major hazard for the road since the debris will most likely be retained in the 5 to 6 m wide catchment ditch (Plate 7).

East: Areas with loose shotcrete and cracking in shotcrete and exposed rock on lateral edges of the north portal face.

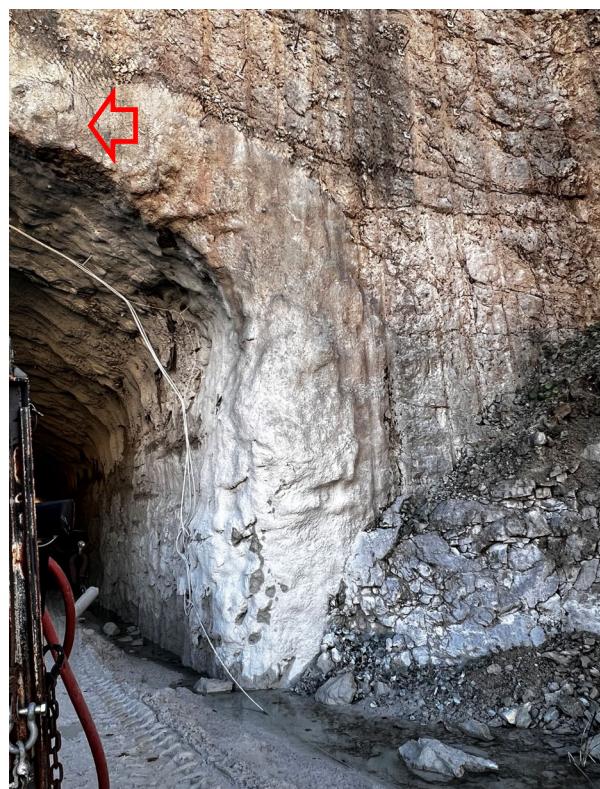
West: Minor cracking in shotcrete on lateral edges of the north portal face.

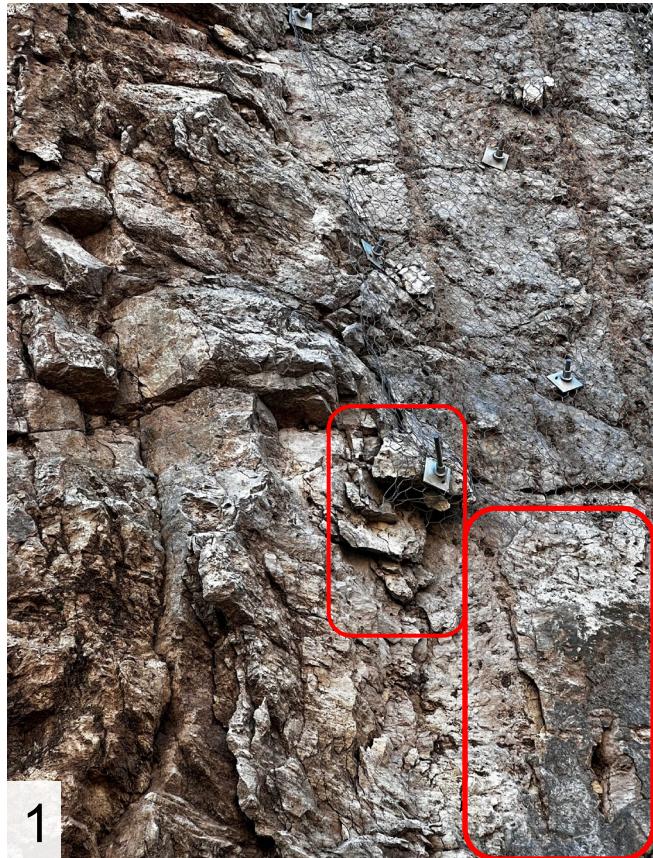
1. Loose rock debris above the east edge of tunnel portal.
2. Area with loose shotcrete and exposed rock mass in the crown above the tunnel opening.
3. Cracked and loose shotcrete and areas with exposed rock mass on the east side above the portal.
4. Rock debris accumulated behind the mesh above the tunnel portal.

- Remove accumulated rock debris on the east side of the north portal and install a concrete jersey type barrier to prevent rockfalls from bouncing or rolling onto the haul road.

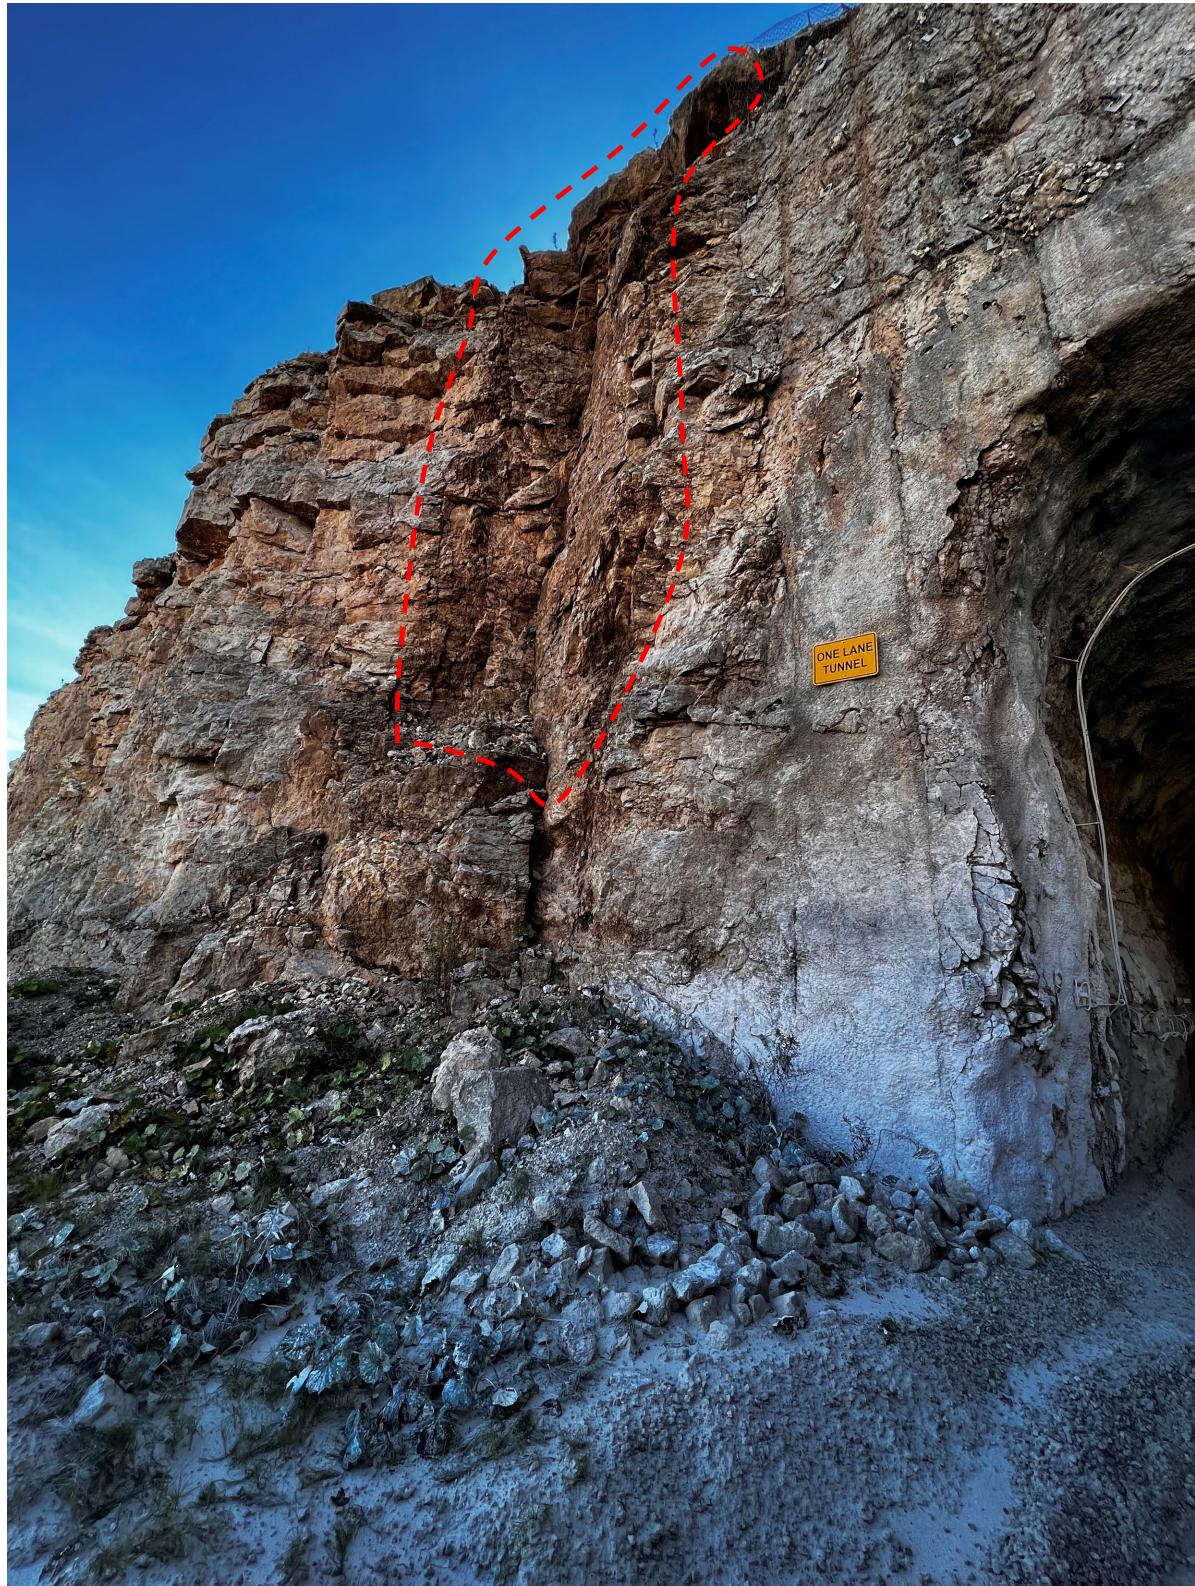
East face adjacent to north tunnel portal: Weathered rock mass with loose blocks and large overhang supported with rock bolts at slope crest. Rock debris accumulated along the rock face toe at tunnel entrance.

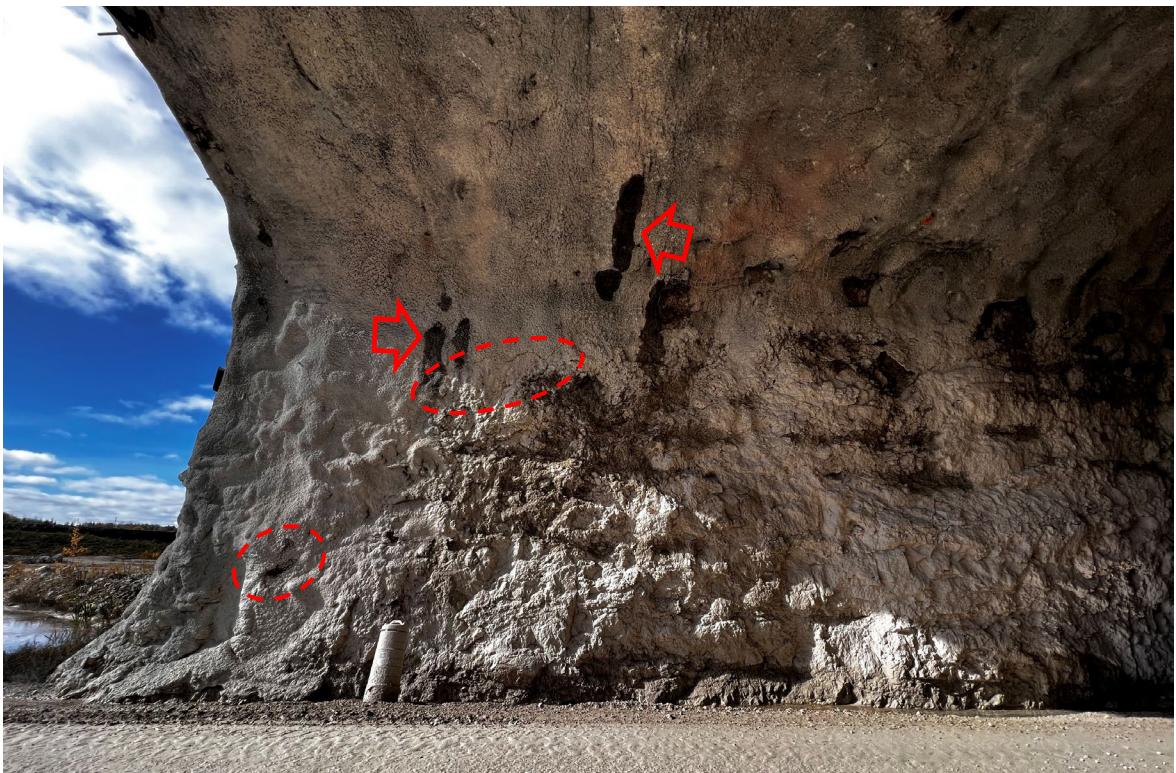
0+00 to 0+10 m. Shotcrete around portal in good condition. Minor cracks noted in shotcrete at 0+02 and 0+06 m (indicated with dashed line circles) and dampness at 0+06 m (arrows).

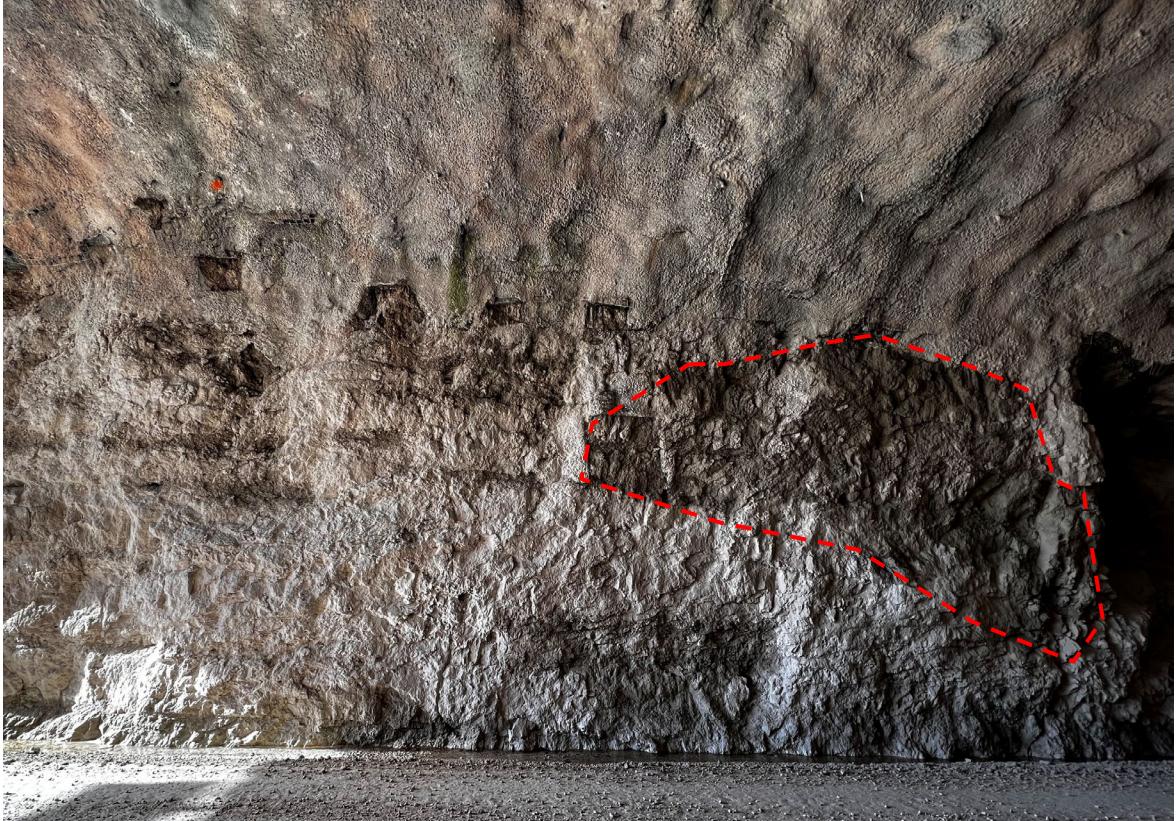
0+10 to 0+20 m. Shotcrete generally very thin in haunches. Some dampness noted along the tunnel haunches near where the water is drained by the drainage panels.

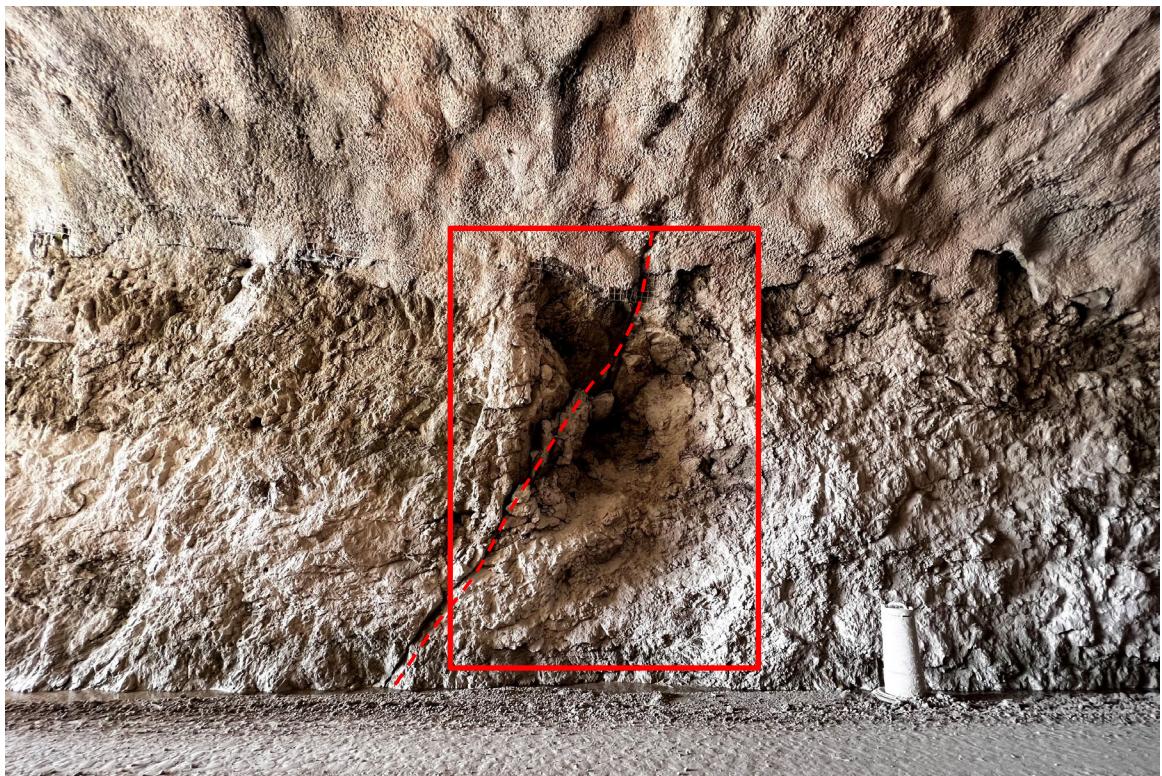
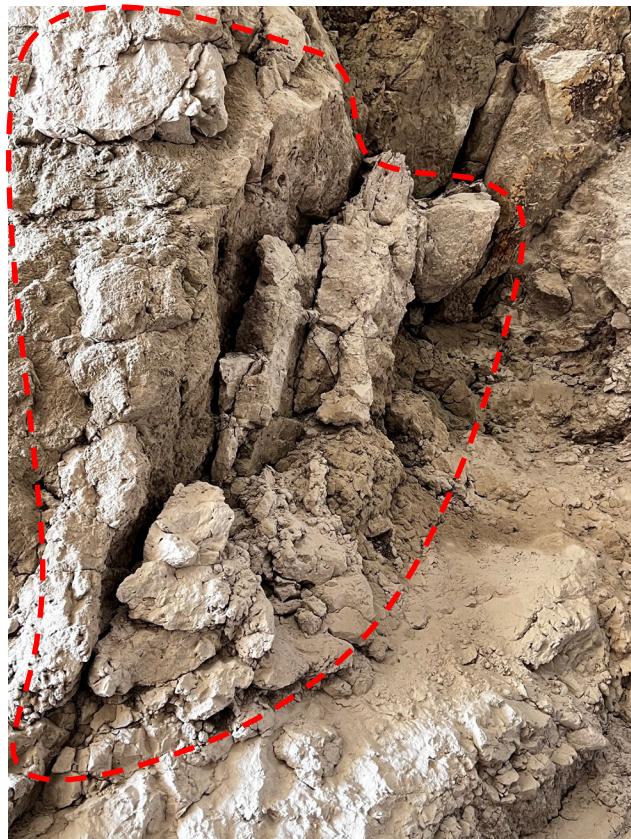
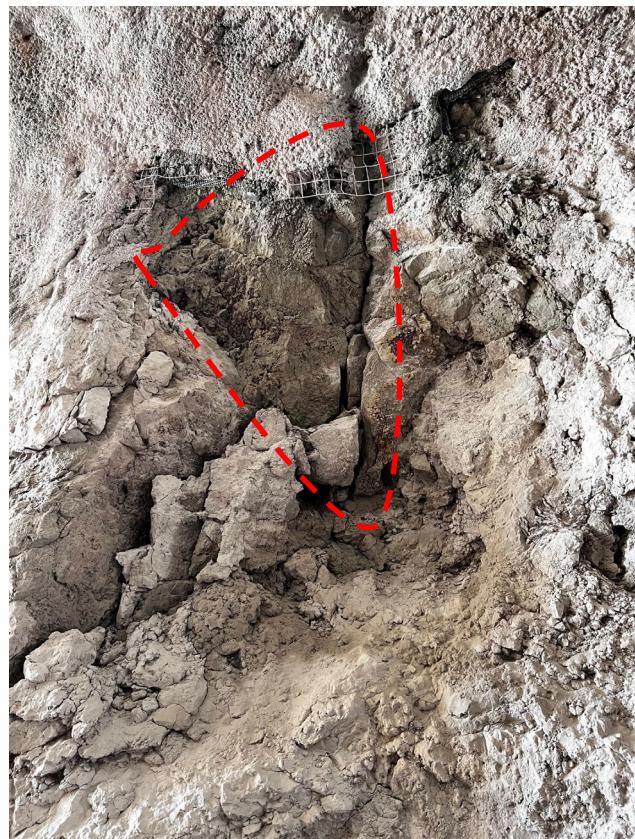
Chainage 0+23 m. Weathered area with open discontinuity (dashed line) and small to medium sized loose blocks (see left below) and a large unsupported block with potential to fall (on right below)

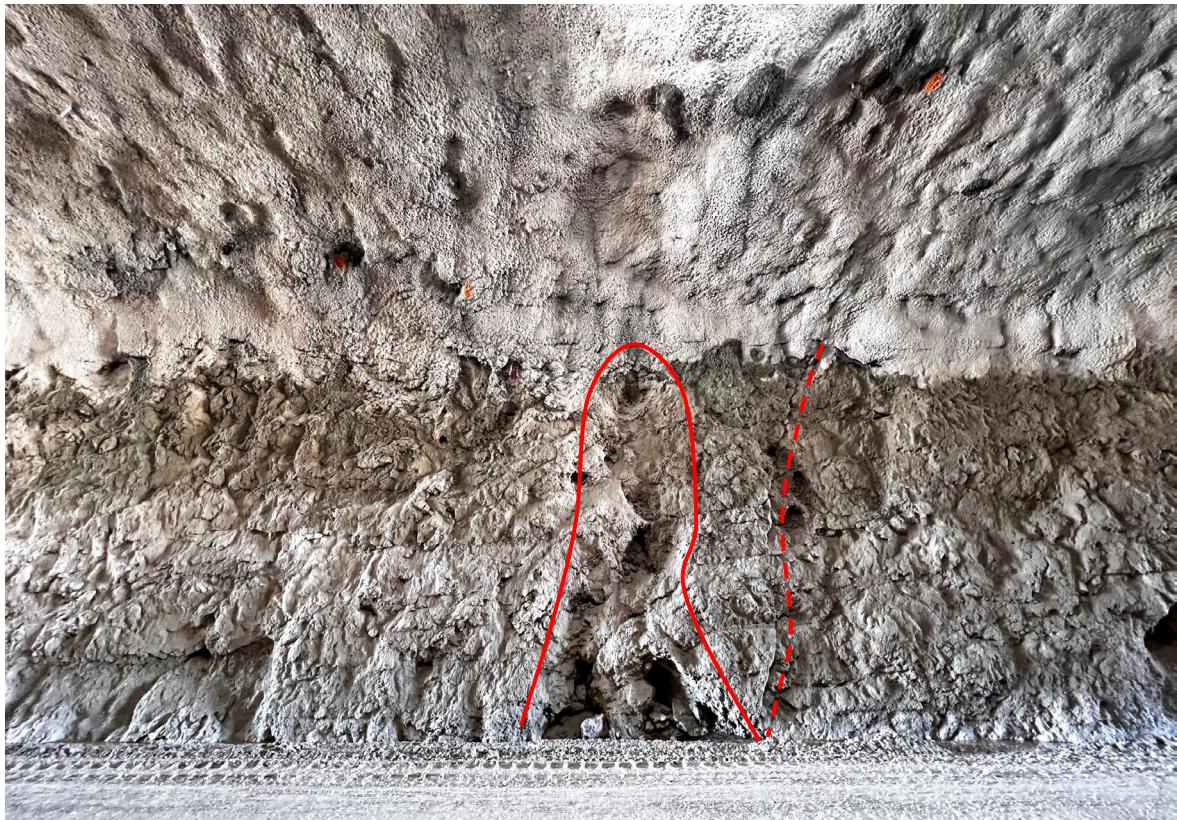
0+40 to 0+50 m. Rock mass appears to be very weathered and blocky resulting in a very rough and irregular tunnel wall surface. Subvertical joint 80°/205° with 1 to 2 cm wide opening at 0+44 m (dashed line).

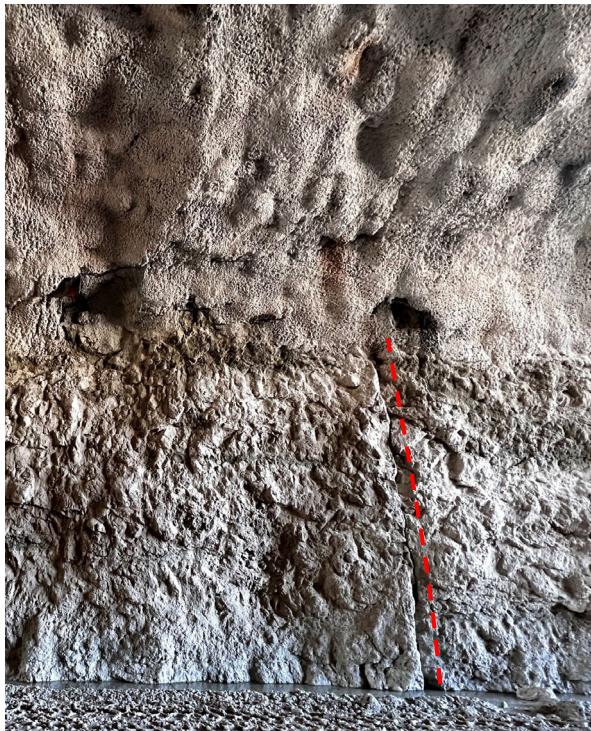
Left: Small loose blocks along the vertical discontinuity (dashed line) at 0+69 m.

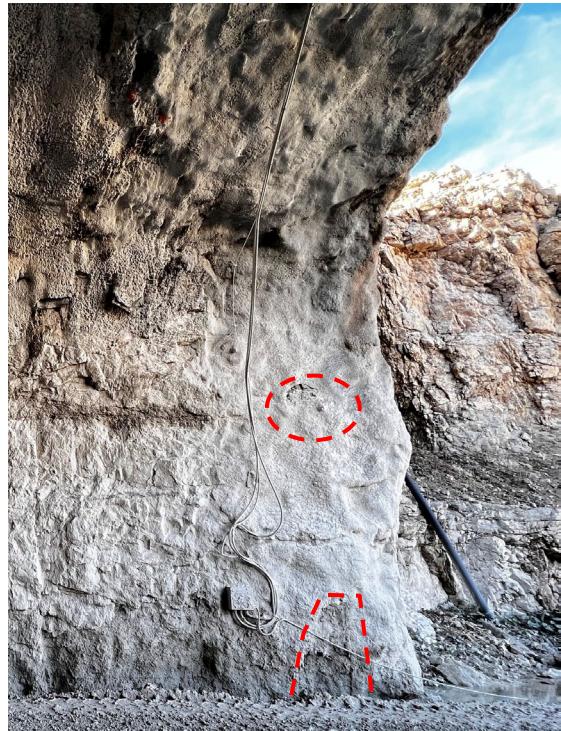
Right: Minor cracks and areas without shotcrete at 0+86 m.

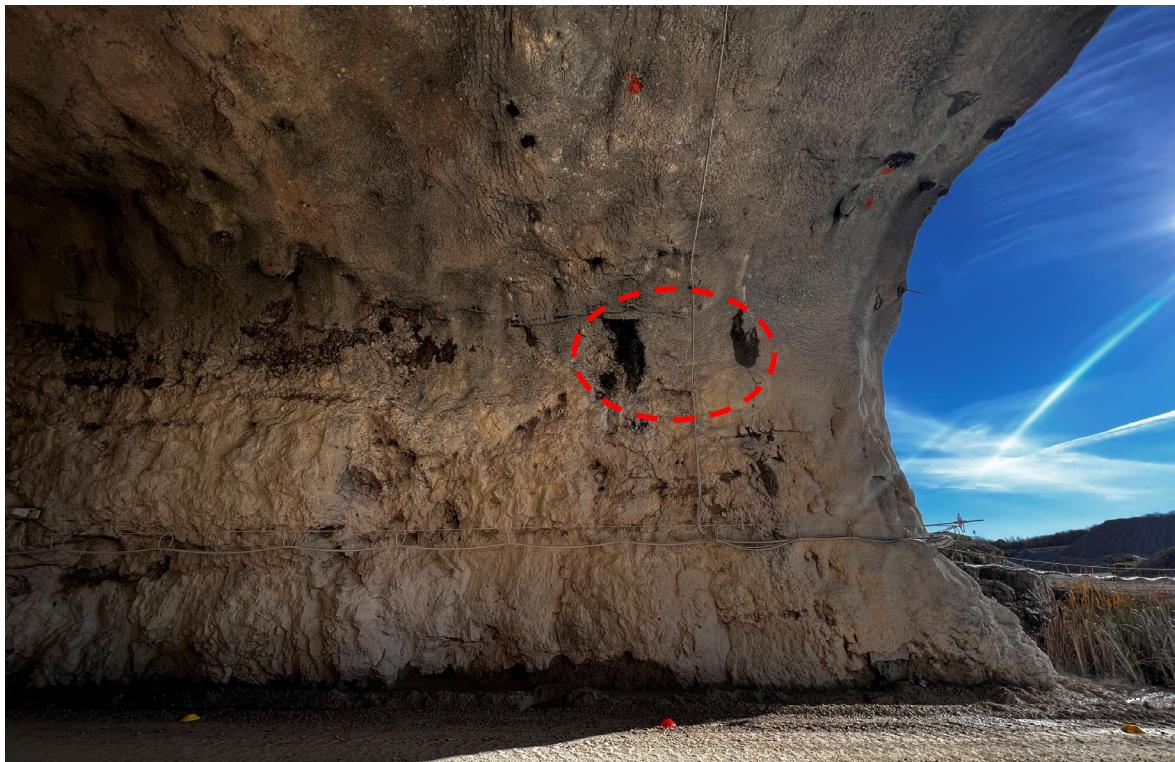
0+00 to 0+10 m. Shotcrete around tunnel portal in good condition. Some dampness noted in tunnel haunches between 0+03 and 0+05 m .

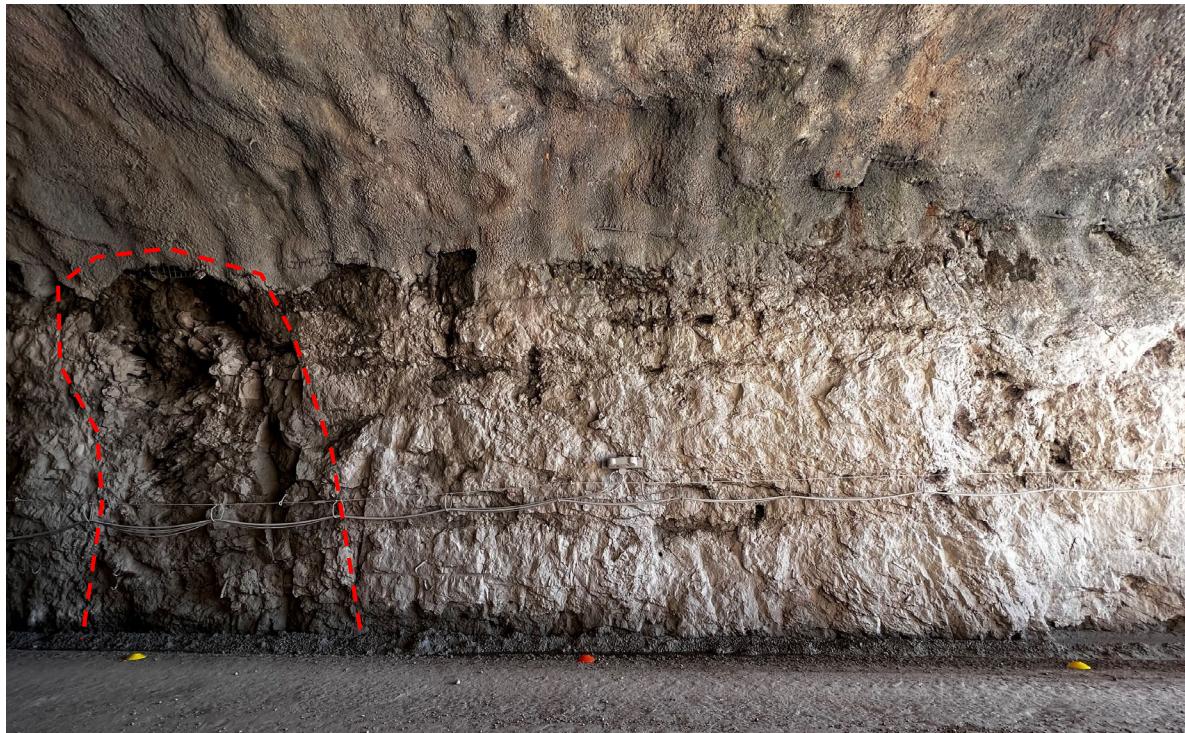
Some features observed in the west wall were also noted along the east wall as well. A zone with weathered and blocky rock along a subvertical discontinuity with an orientation of 75°/195° (dip/dip direction) was noted between chainage 0+19 and 0+22 m. This rock appears to be related to the weathered zone at a similar chainage noted along the west wall (Plate 11). The upper area is undermined, and some blocks appear to be loose. Consideration should be given to scaling any loose rock and applying mesh reinforced shotcrete to prevent further weathering

0+10 to 0+20 m. Weathered undermined zone between 0+19 and 0+22 m with some small loose blocks (dashed line)

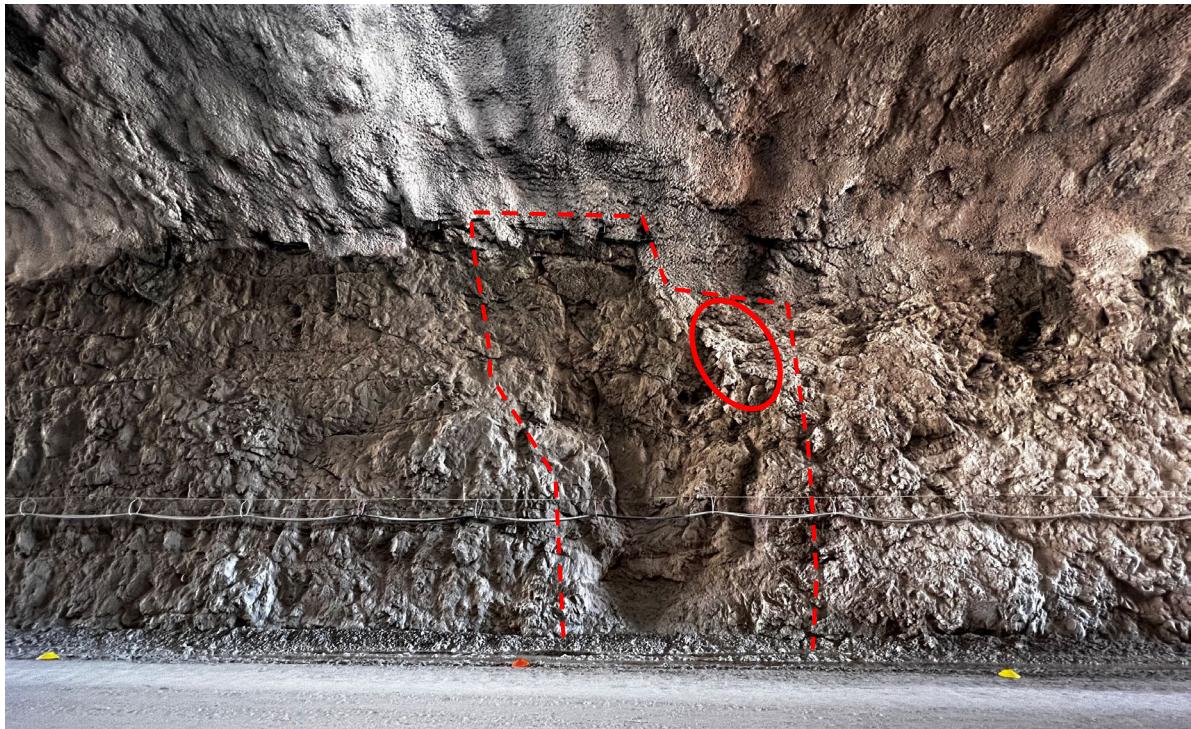
Chainage 0+40 to 0+50 m. Very weathered and blocky rock mass with some undermined areas. Undermined zone and detached block with shotcrete at chainage 0+43 m.

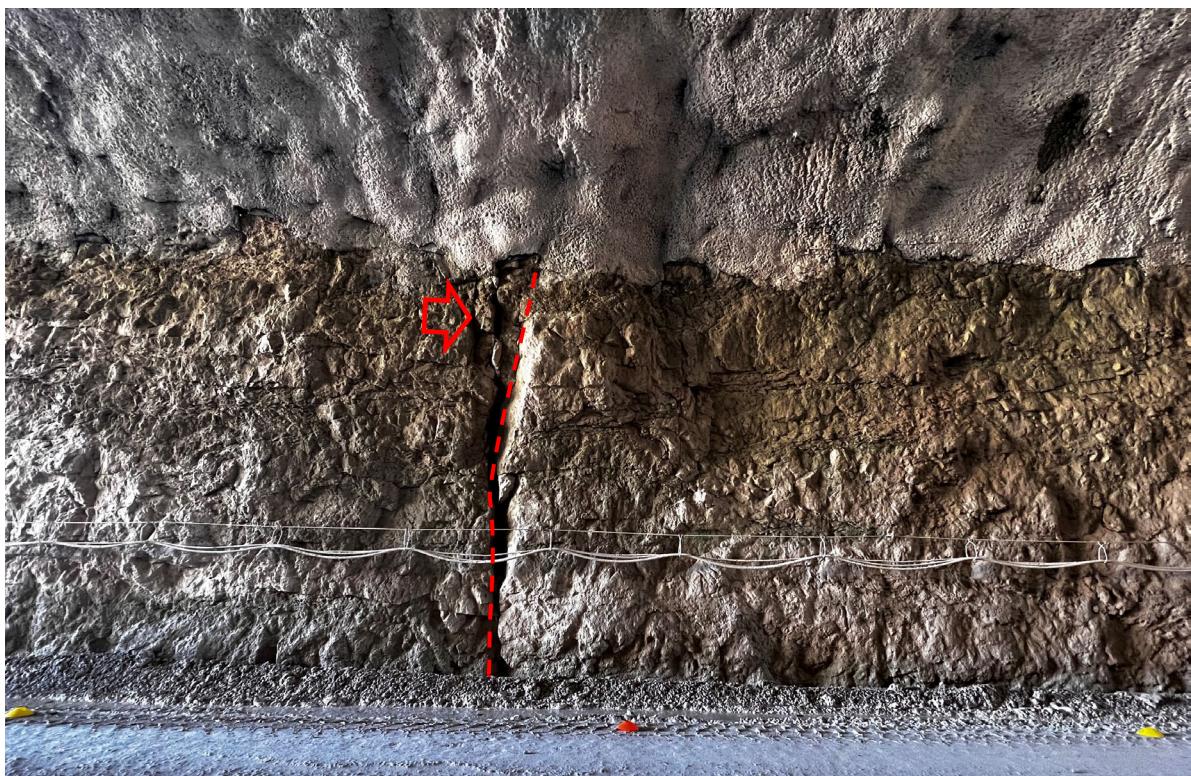
Chainage 0+60 to 0+70 m. Vertical discontinuity at 0+66 m with wide opening and some keyed in wedges (indicated with an arrow) in the upper area.
