October 15, 2025

Reference No. CA0012787.0623-001-RPT-Rev0

## REPORT – GEOTECHNICAL INSPECTION OF THE HAULAGE TUNNEL AT THE DUNTROON QUARRY

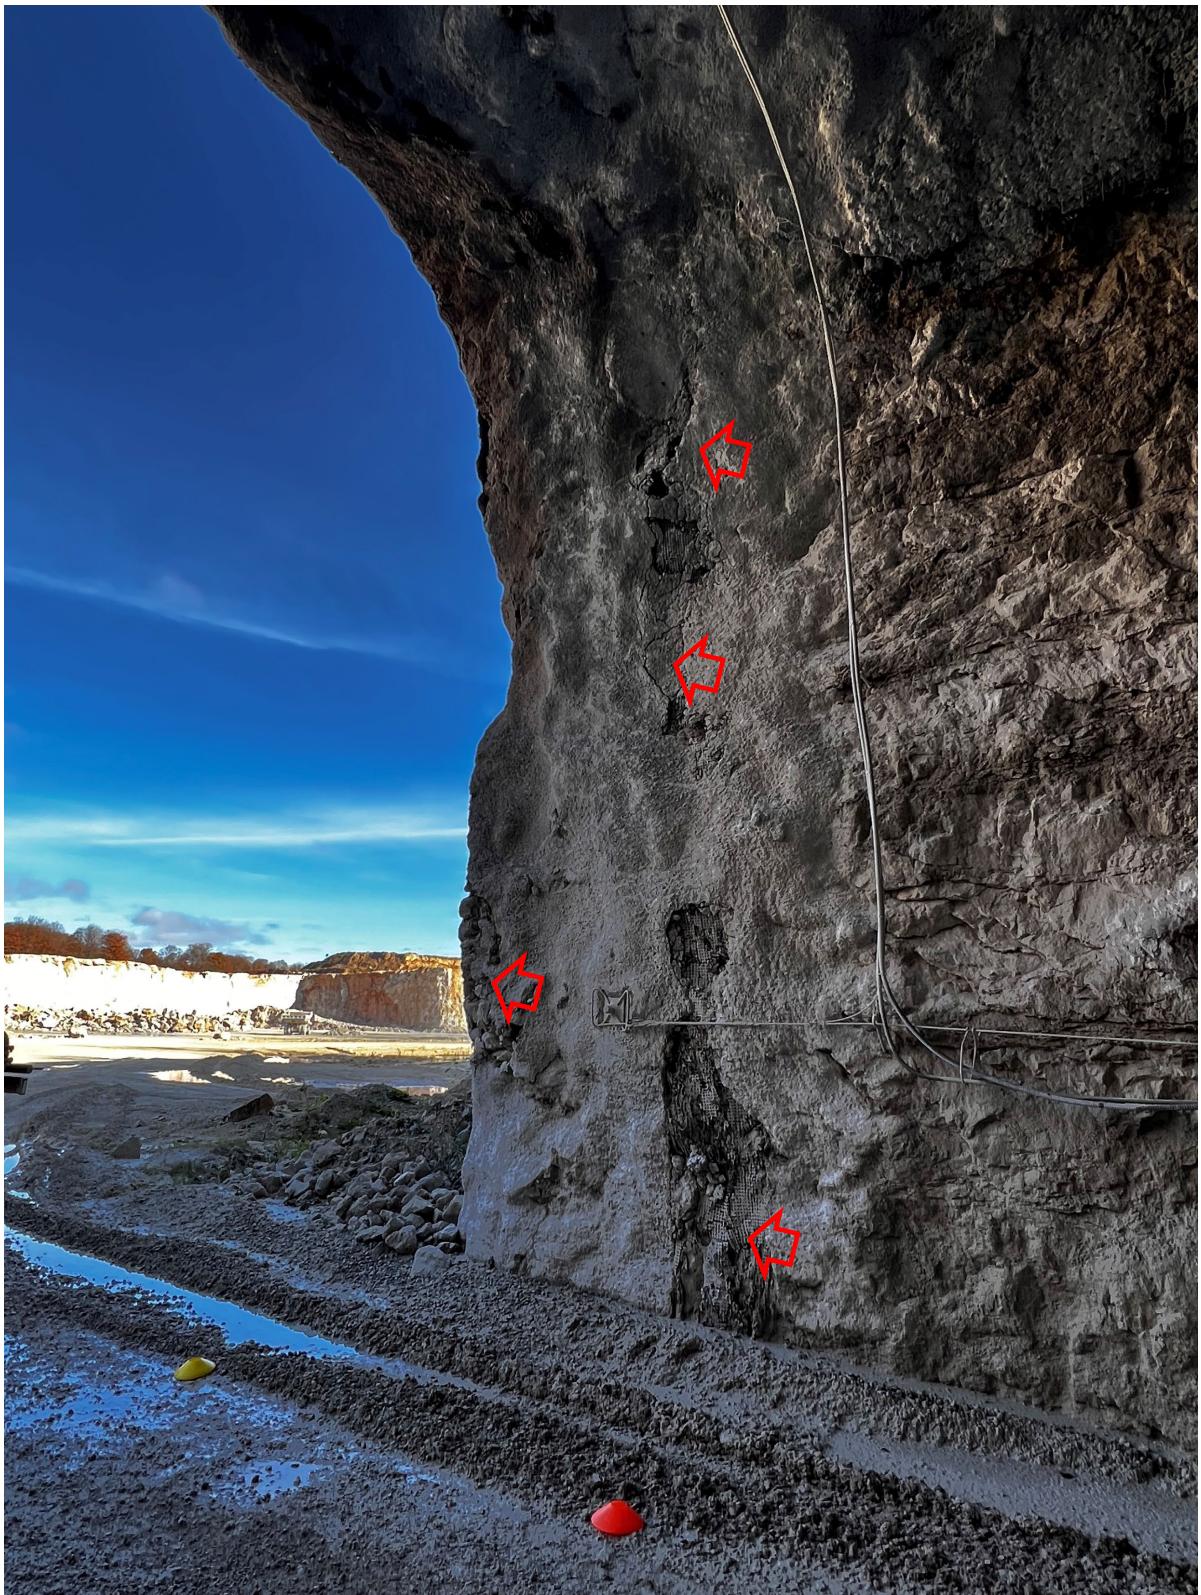
Shotcrete cracking and areas with exposed rock observed near the north portal.

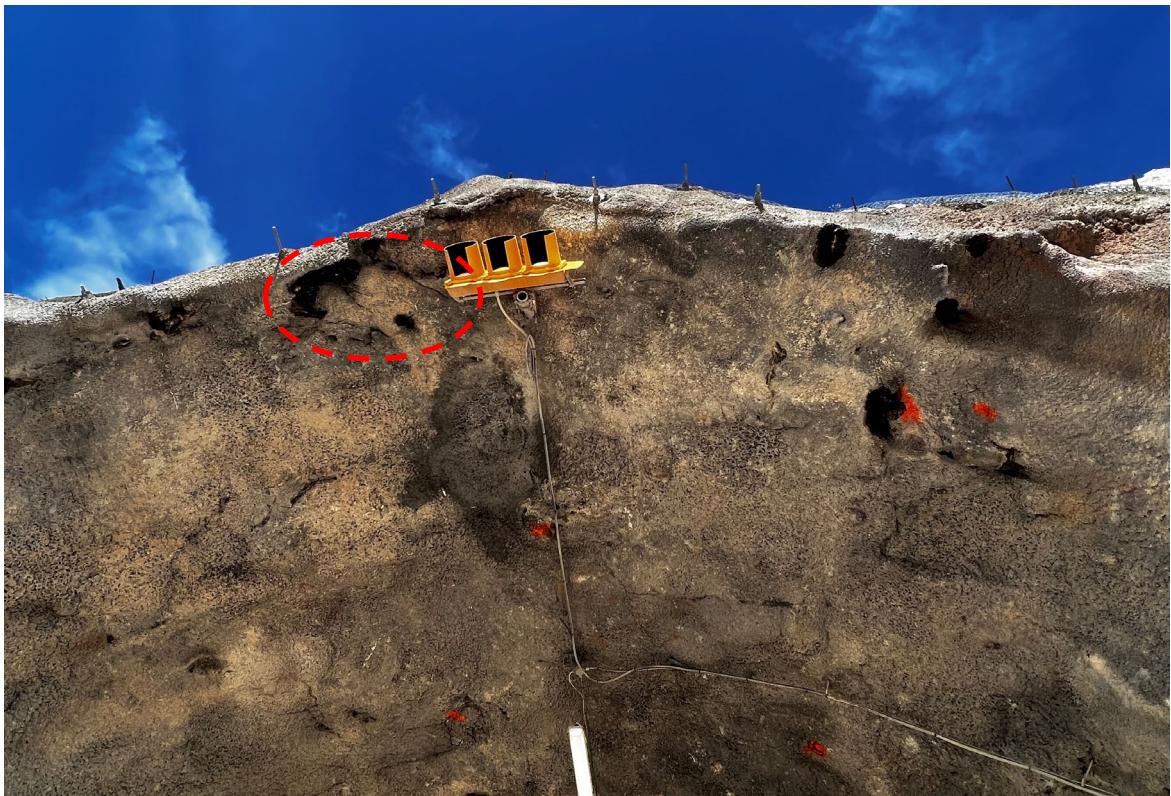
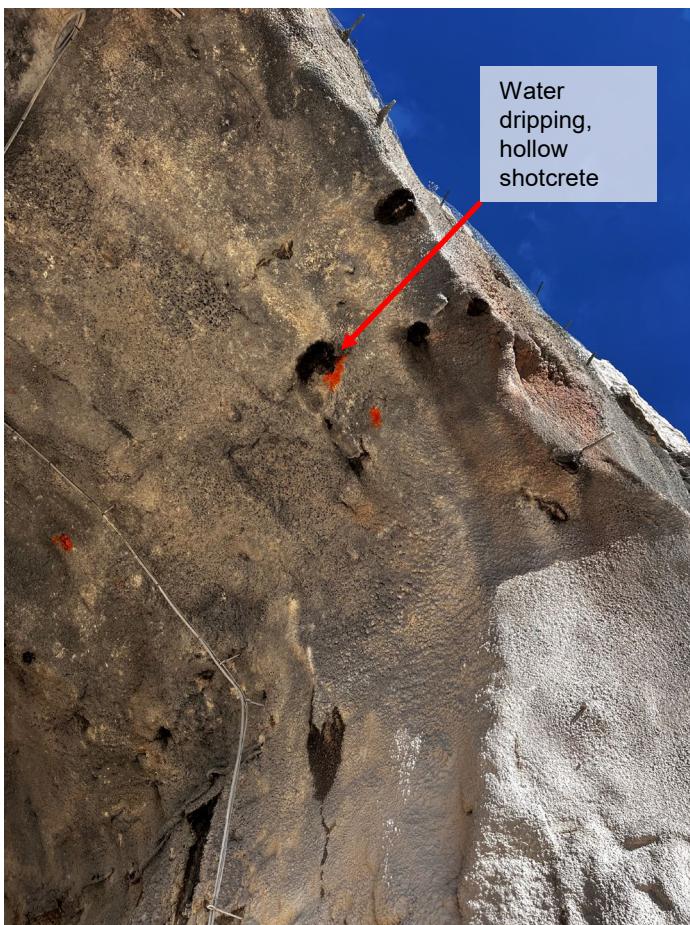
## TUNNEL CROWN AT SOUTH PORTAL

Overview of crown at south portal. Mesh reinforced shotcrete in good condition, with some minor cracking (red circle) and hollow areas (indicated with orange spray paint) mostly noted in areas with thin shotcrete layer and in places with drainage membrane visible. Water dripping from 12:30 o'clock position.

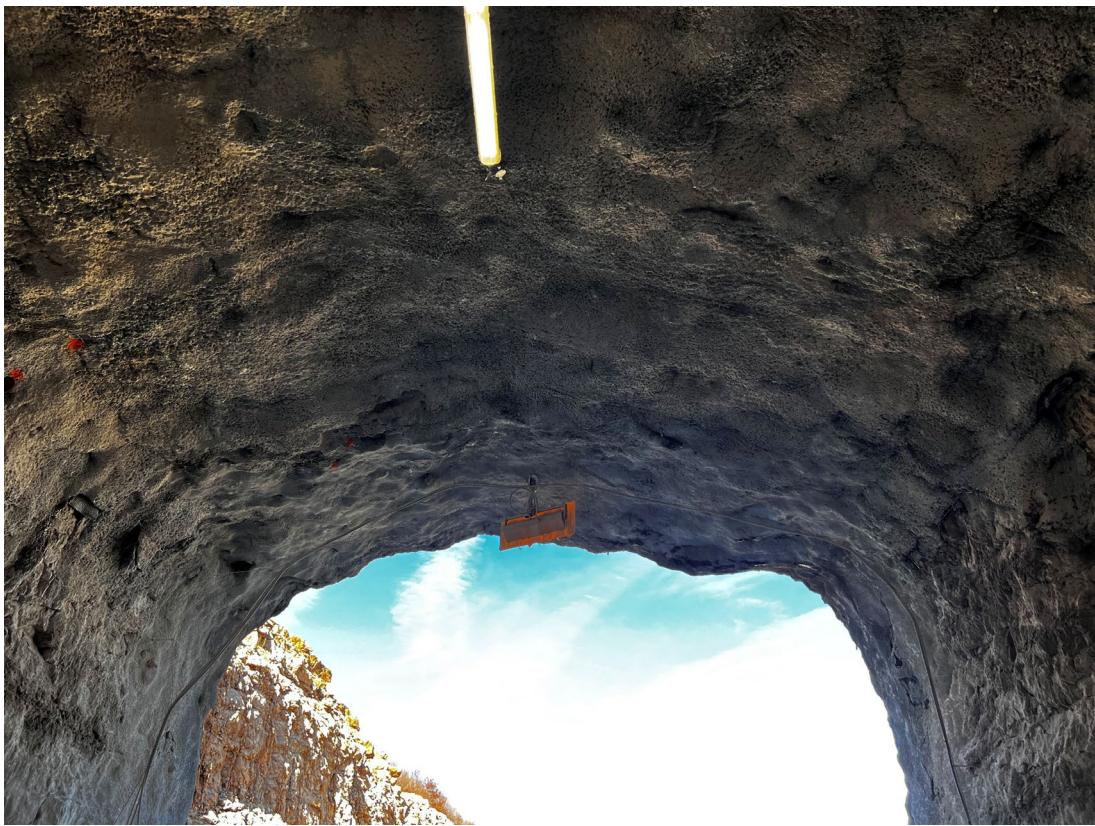
Overview of crown near North Portal. Shotcrete in good condition in the crown. Areas of hollow and cracked shotcrete smaller areas with exposed wire mesh and rock mass (in red below).

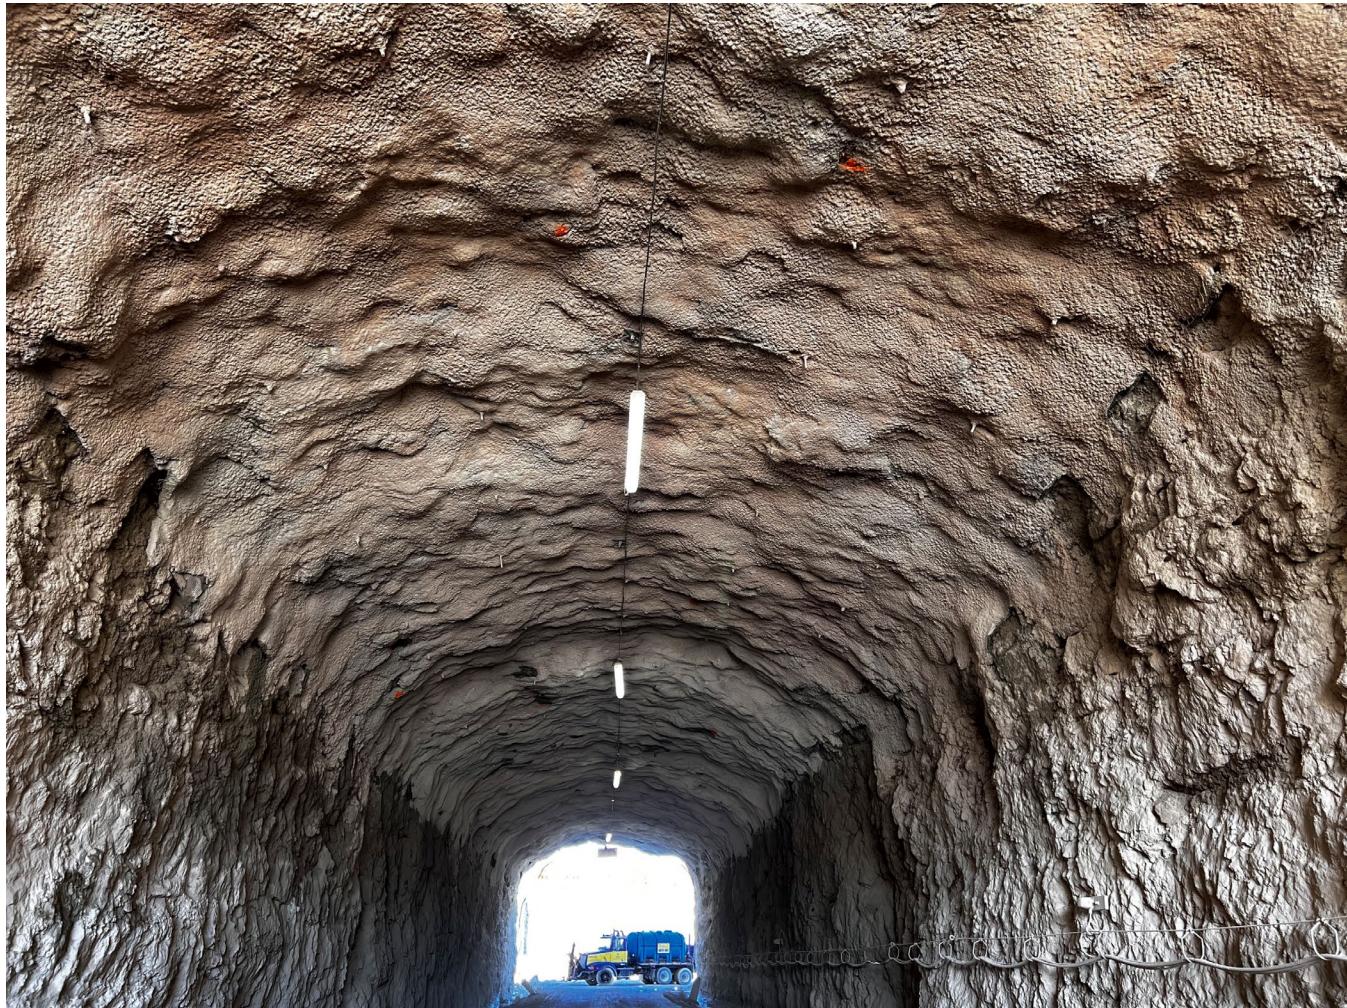
Overview of shotcrete condition in the crown at chainage 0+45 m toward the North Portal. Dry conditions with some hollow areas.

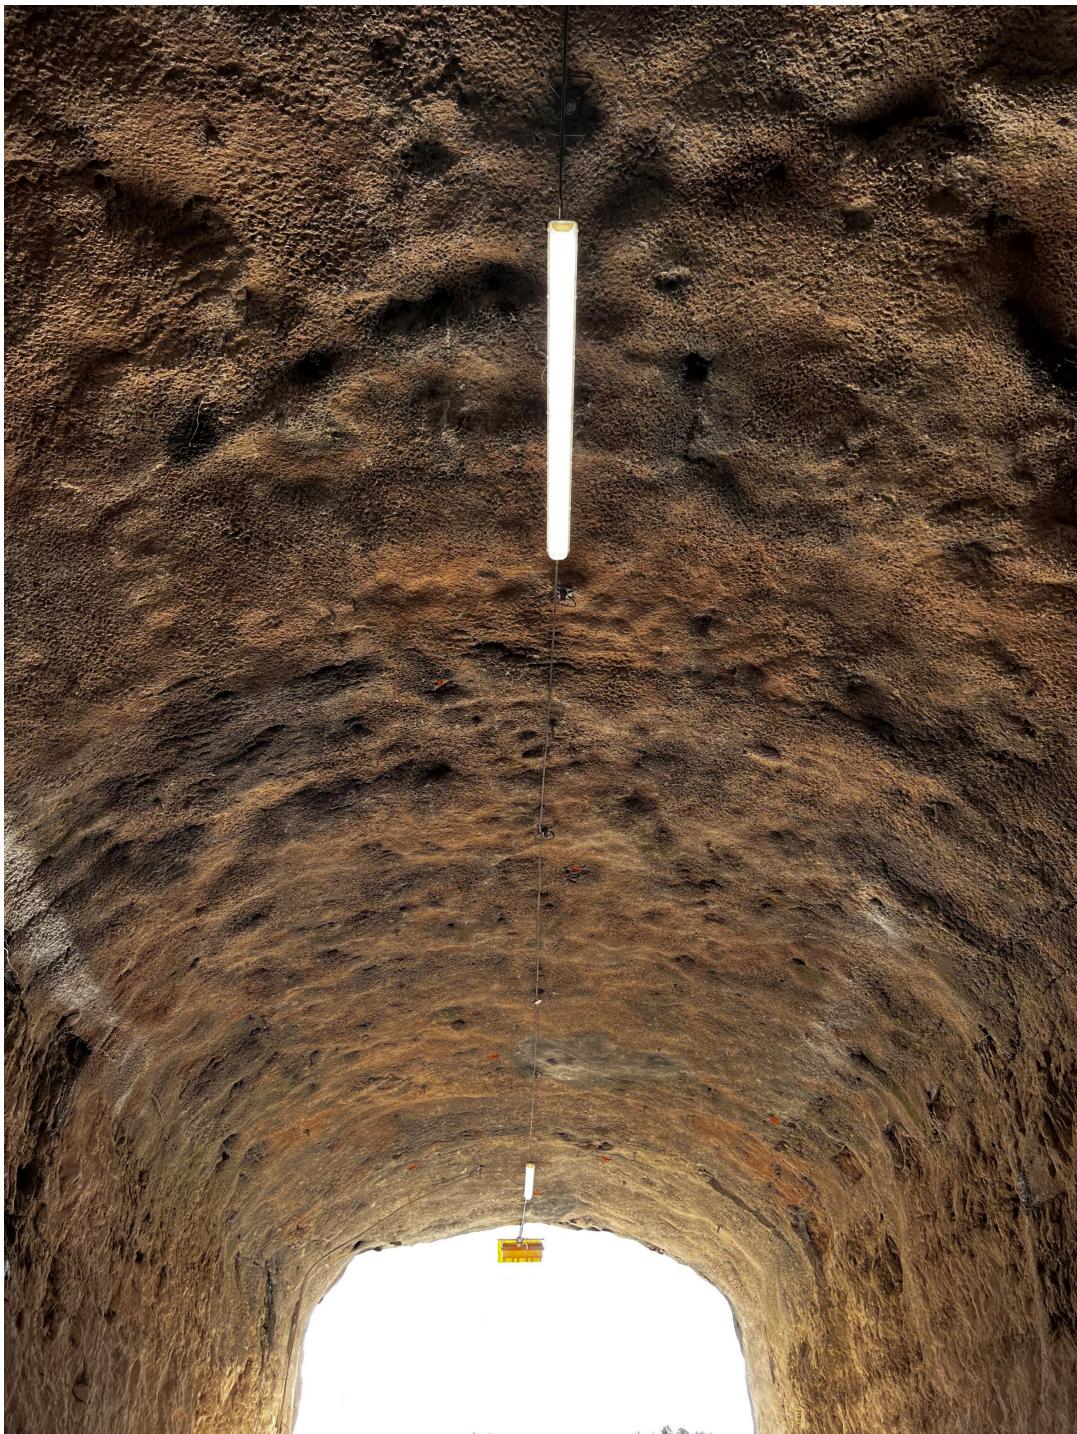
Tunnel crown near 0+20 m looking toward the South Portal. Crown in good condition with several hollow areas, mostly noted around 12 o'clock position. Dry conditions.
