# 7582 COUNTY ROAD 9 & 267 COLLINGWOOD ST, CLEARVIEW, ON

PROJECT NO. LA 910-24

DRAWING:  
**EXISTING CONDITIONS**

DRAWING:  
**TREE PROTECTION PLAN I**

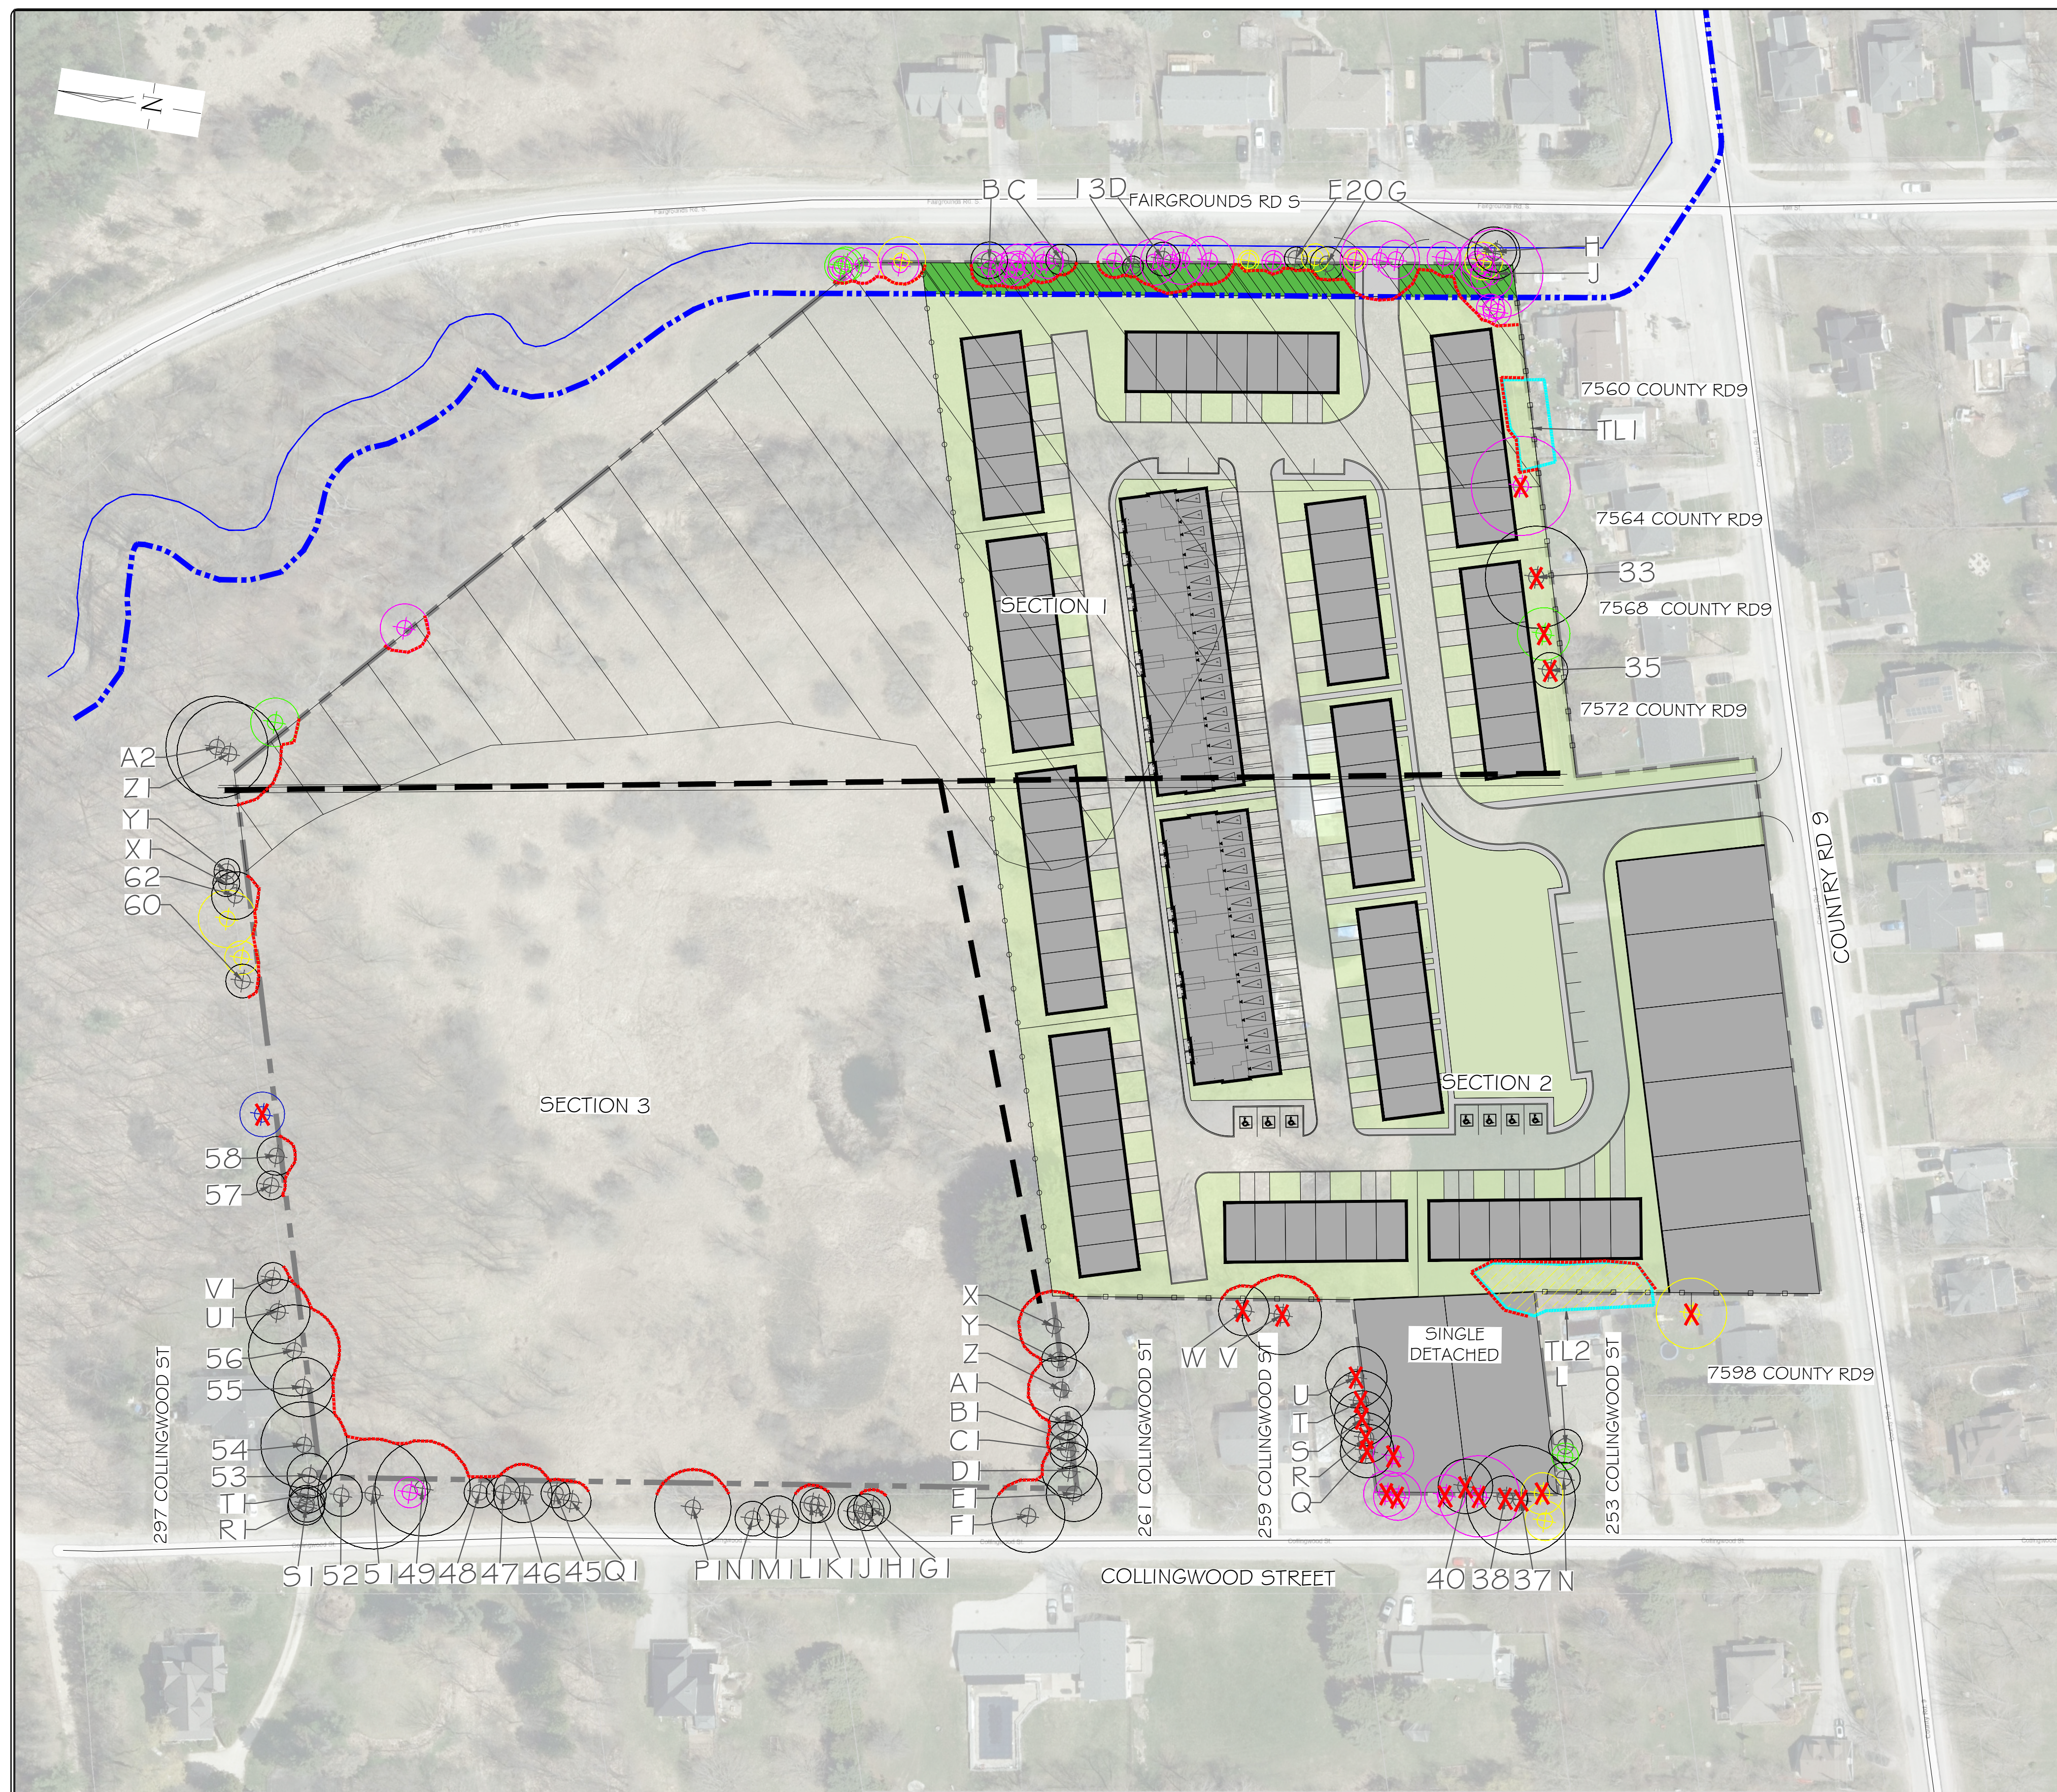
DRAWN BY: D.L, J.M, E.F  
 CHECKED BY: J.H  
 DRAWING No.: TP-1

- LEGEND
- PROPERTY BOUNDARY
  - ⊕ TREE LOCATION WITH CANOPY
  - ⊕ OFFSITE TREE LOCATION WITH CANOPY
  - TREE PRESERVATION FENCING
  - TREE GROUPING CANOPY LINES
  - X TREE TO BE REMOVED

The tree species included in this table are, Manitoba Maples & Norway Maples which are considered invasive, White Ashes that are infected with Emerald Ash Borer, & Apple Spp.

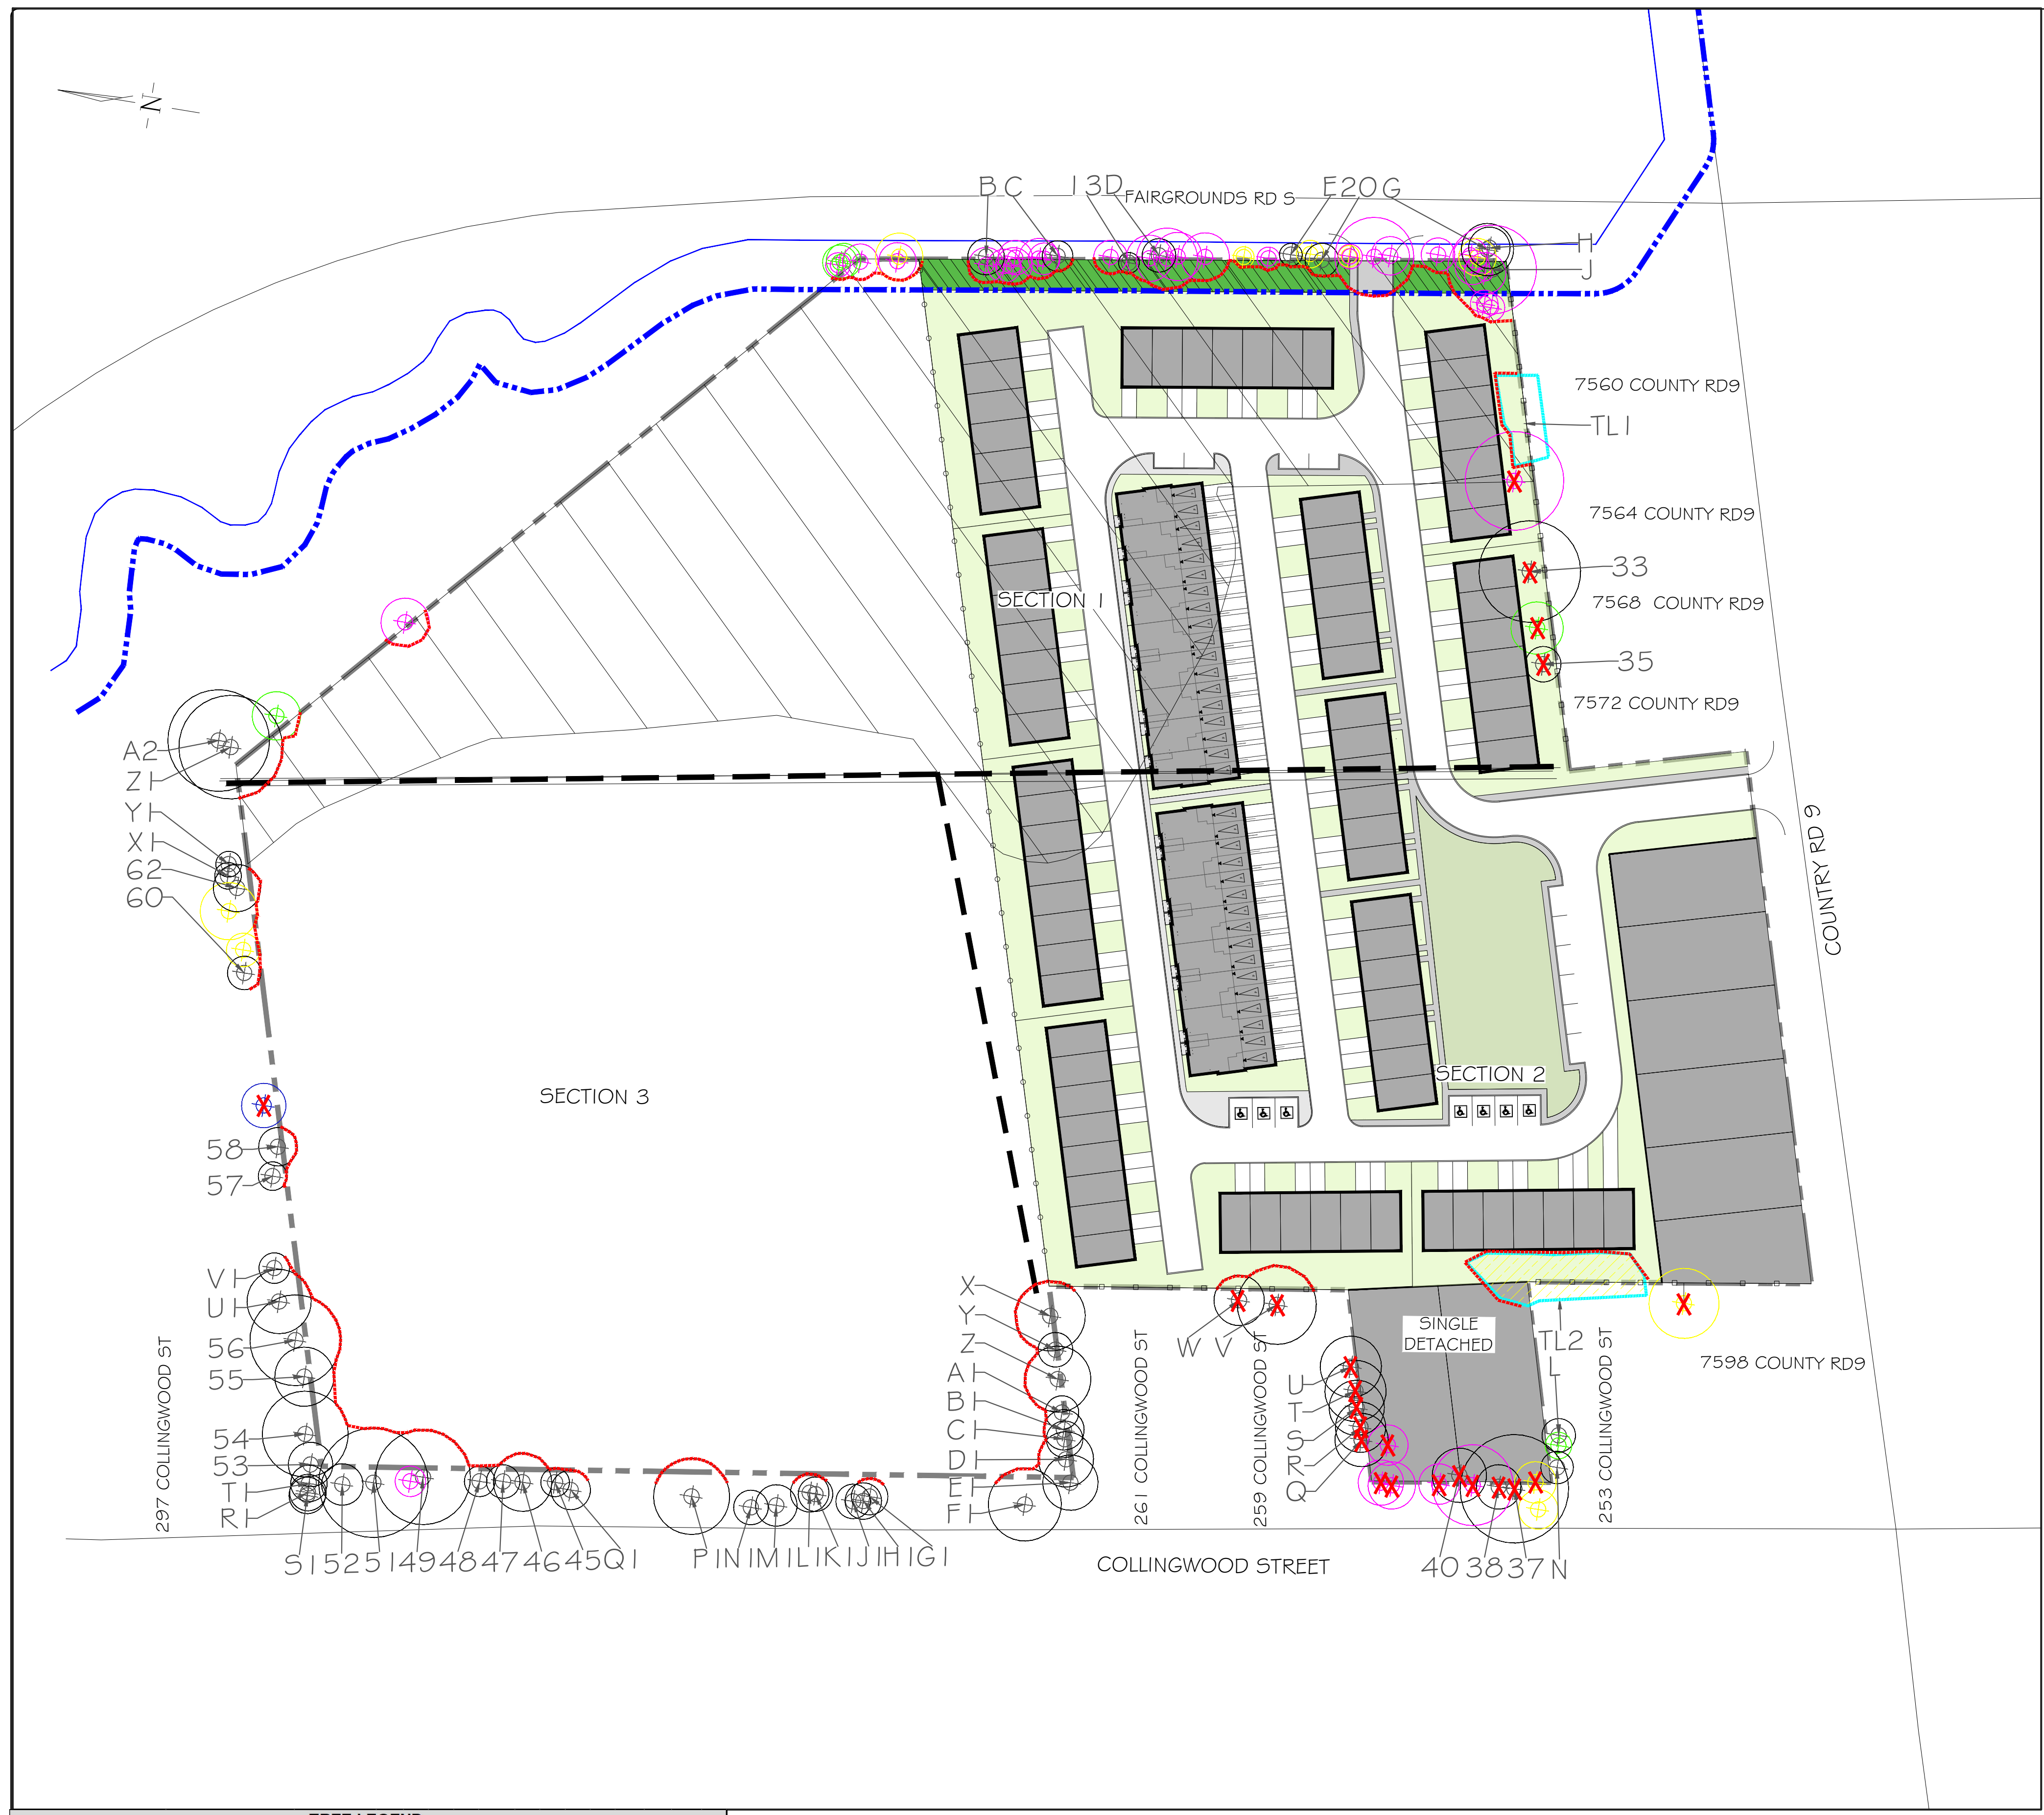
DRAWN BY: D.L, J.M, E.F  
 CHECKED BY: J.H  
 DRAWING No.: TP-2

DRAWING:  
**TREE PROTECTION PLAN 2**

The tree species included in this table are, Manitoba Maples & Norway Maples which are considered invasive, White Ashes that are infected with Emerald Ash Borer, & Apple Spp.
