October 15, 2025

Reference No. CA0012787.0623-001-RPT-Rev0

## REPORT – GEOTECHNICAL INSPECTION OF THE HAULAGE TUNNEL AT THE DUNTROON QUARRY

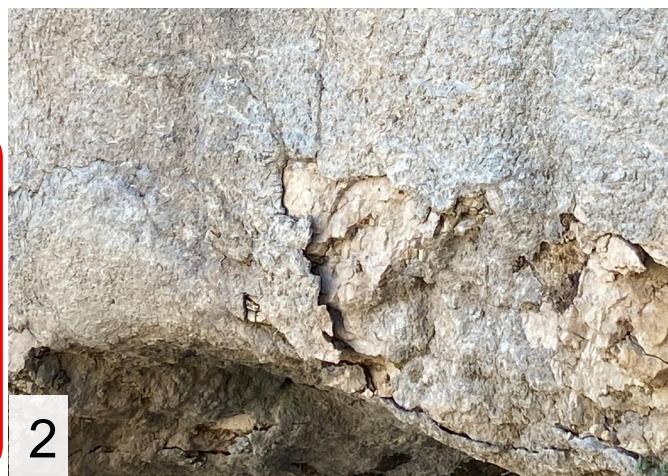
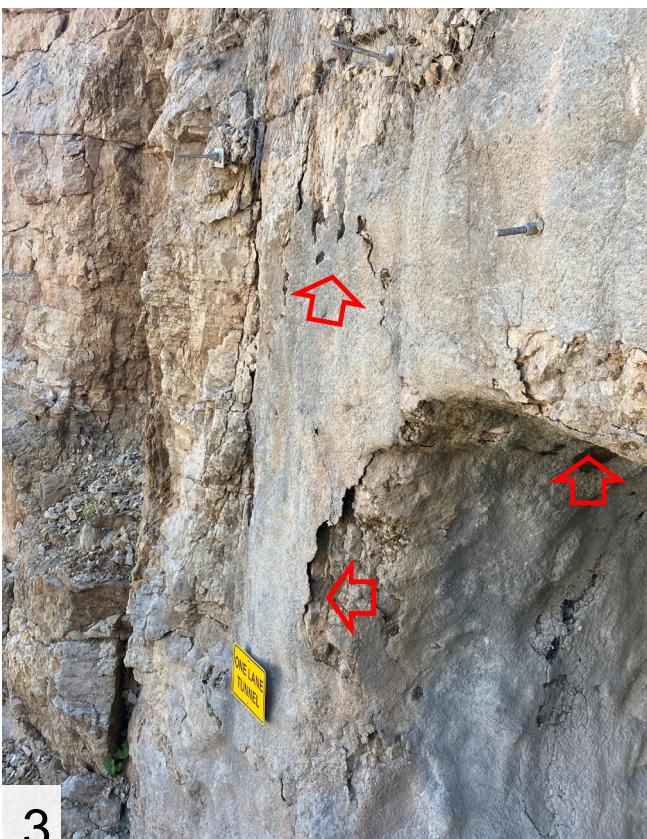
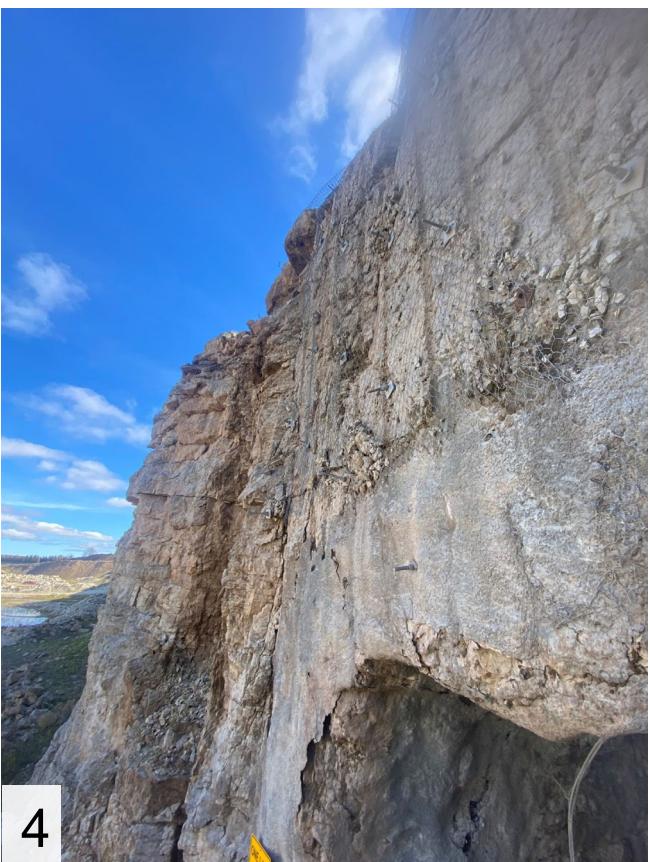
1. Loose rock debris above the east edge of tunnel portal.
2. Area with loose shotcrete and exposed rock mass in the crown above the tunnel opening.
3. Cracked and loose shotcrete and areas with exposed rock mass on the east side above the portal.
4. Rock debris accumulated behind the mesh above the tunnel portal.

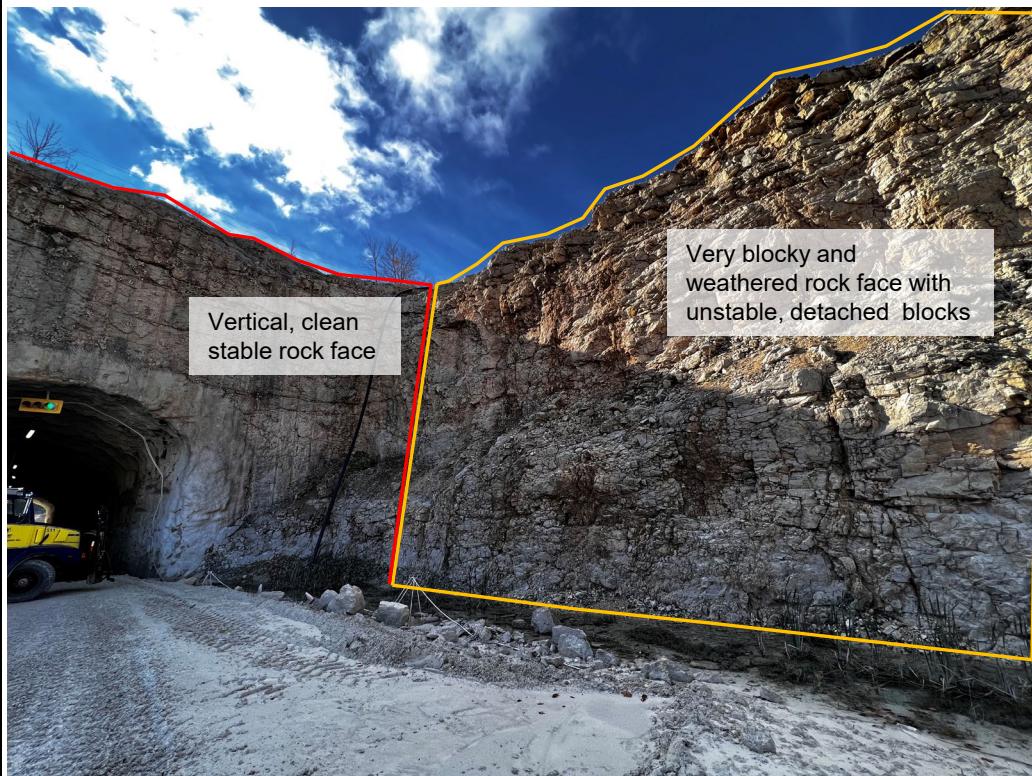
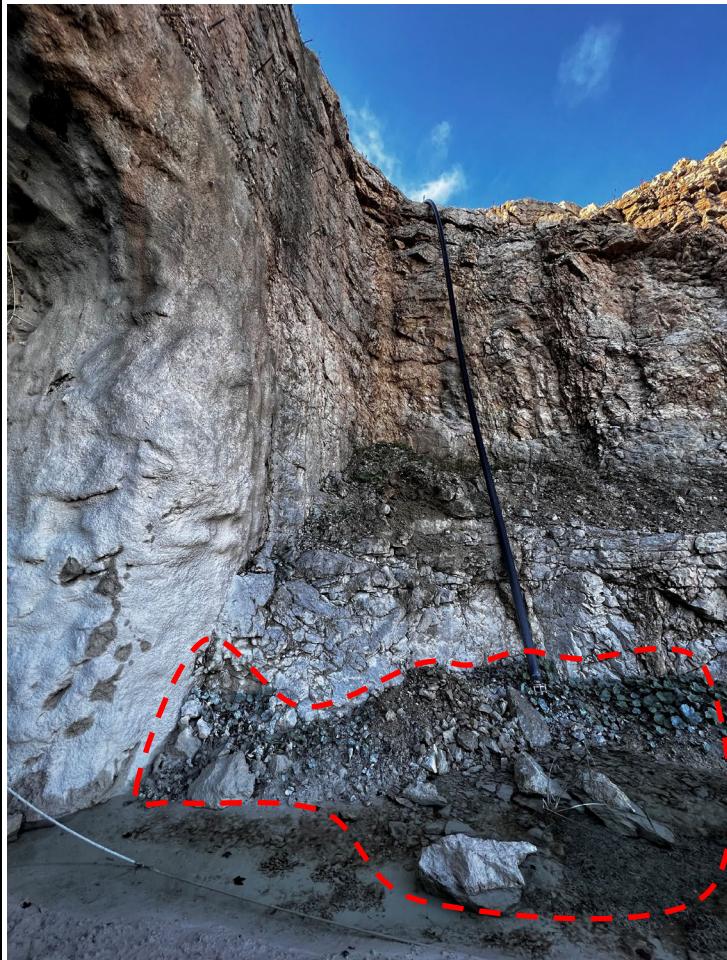
East face adjacent to north tunnel portal: Weathered rock mass with loose blocks and large overhang supported with rock bolts at slope crest. Rock debris accumulated along the rock face toe at tunnel entrance.

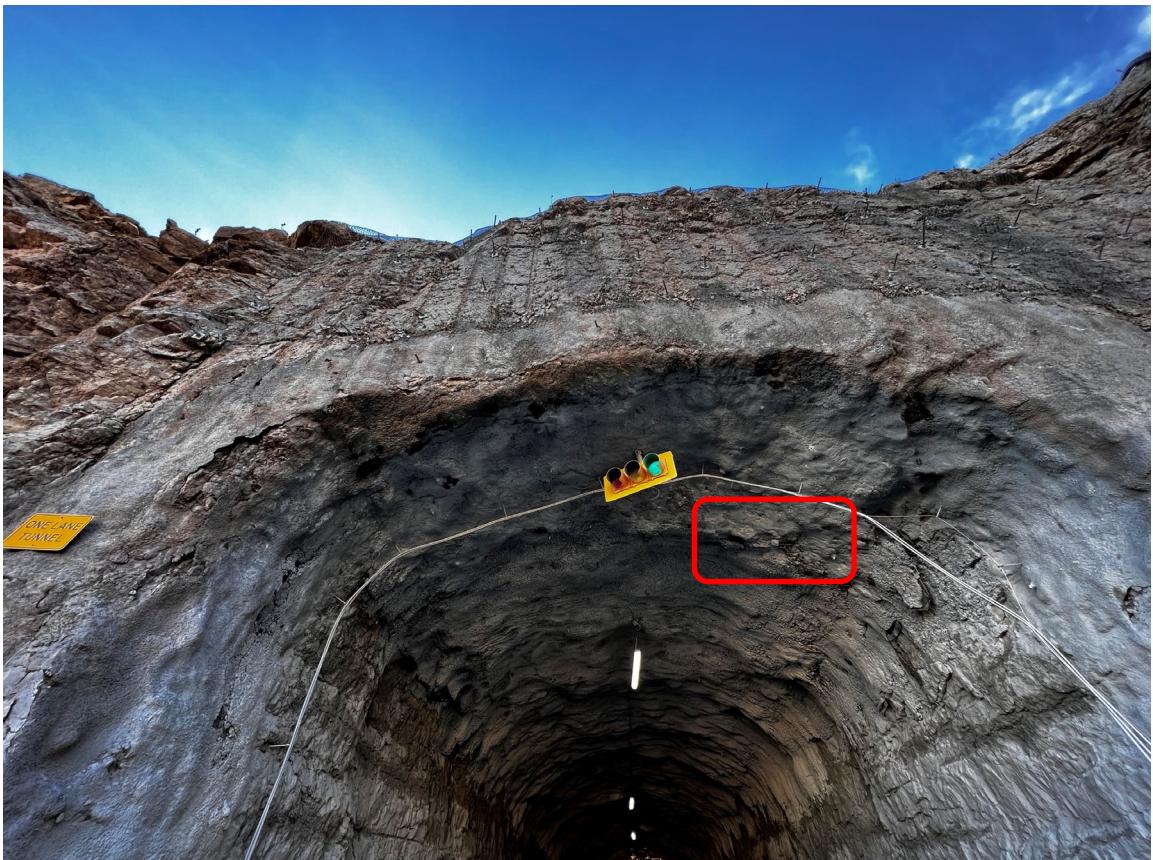
Overview of crown near North Portal. Shotcrete in good condition in the crown. Areas of hollow and cracked shotcrete smaller areas with exposed wire mesh and rock mass (in red below).
