## Lighting Calculation Study

Project name: Agripharm Bildig - 2741 Count Rd 42 - Clearview - Ont - Site - r10 - Feb 7-2019.AGI

Prepared For: Steve Stanton @ AMG Baytech / Wallwin Electric

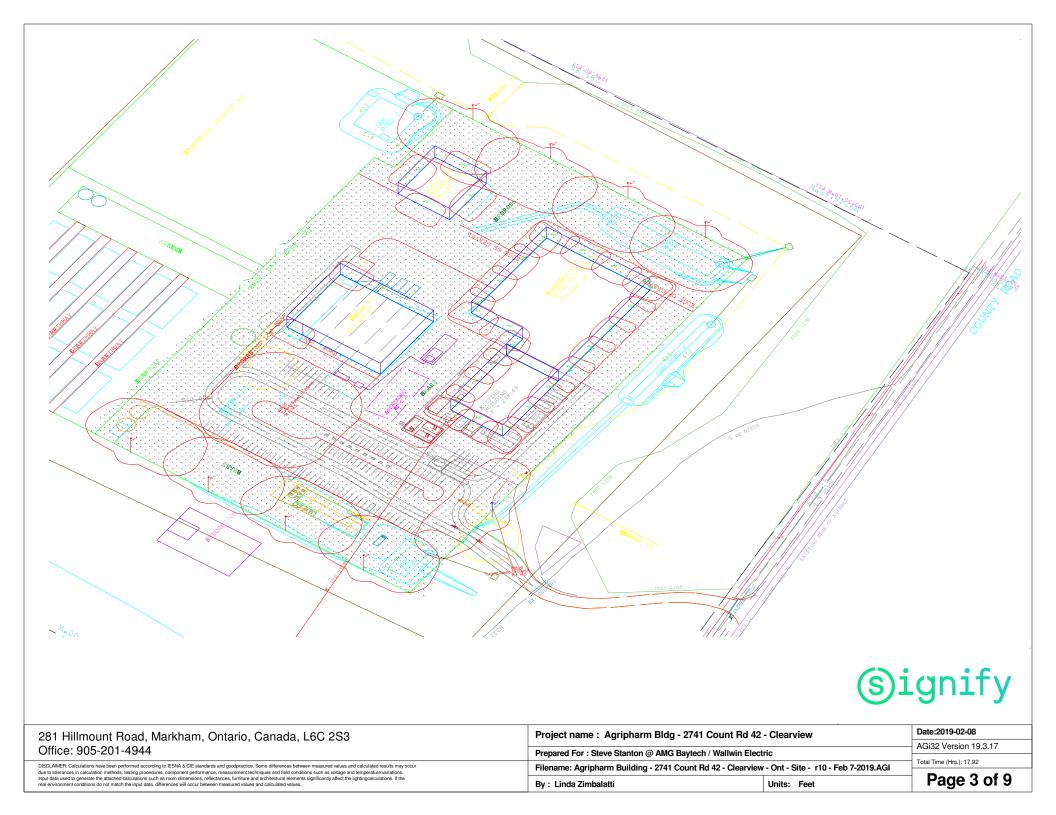
## **Results summary**

Luminaire Schedule								
Symbol	Qty	Label	Arrangement	LLF	Description	Lum. Watts	Lum. Lumens	[MANUFAC]
	31	W1	SINGLE	0.900	LPW32-7	70.5	6910	SIGNIFY STONCO/KEENE
	8	P1	SINGLE	0.900	ECF-L-96L-1_2A-NW-G2-4-HIS	365	32742	SIGNIFY GARDCO
	1	P2	SINGLE	0.900	ECF-L-96L-1_2A-NW-G2-3-HIS	365	31723	SIGNIFY GARDCO
	1	P3	SINGLE	0.900	ECF-L-96L-1_2A-NW-G2-5W	365	41559	SIGNIFY GARDCO

Calculation Summary									
Label	CalcType	Units	Avg	Max	Min	Avg/Min	Max/Min		
SITE	Illuminance	Fc	0.86	7.5	0.0	N.A.	N.A.
